# TATTINGSTONE

Paper submitted by the Clerk to the Council at the Parish Council meeting on 04 March 2024

### Parish Clerk's Report – March 2024

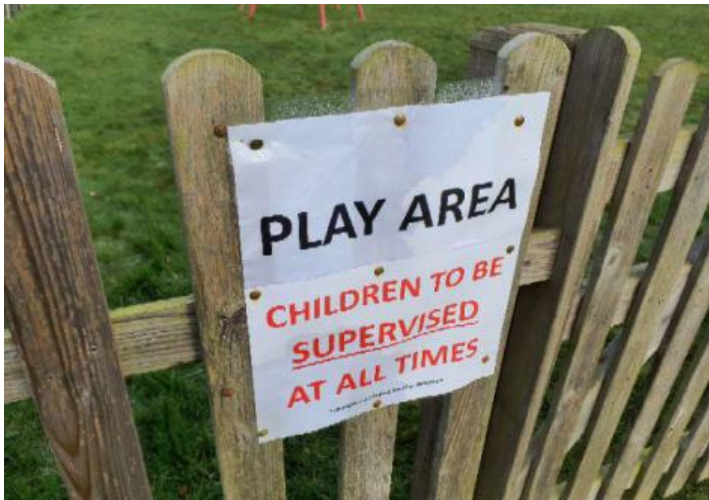
**Item:** Ancillary Items - Sign  
**Manufacturer:** Owner/Operator

**Finding:** It is recommended that signage, with information including the site address, contact information for maintenance issues and emergency contact details are provided for the facility

**Action:** Provide in accordance with the recommendations

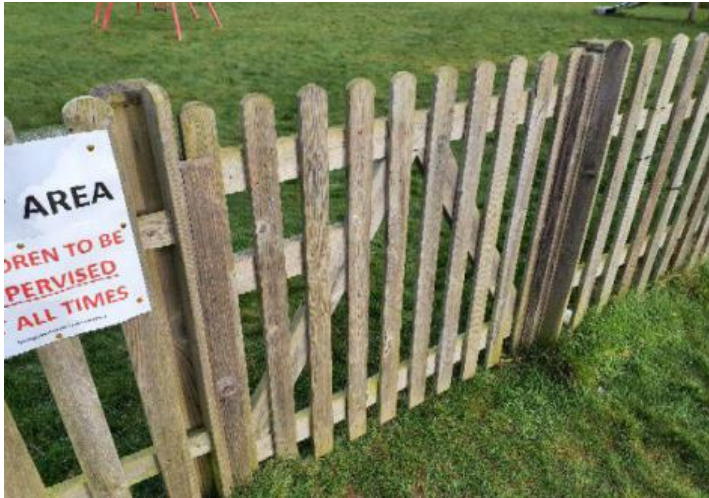
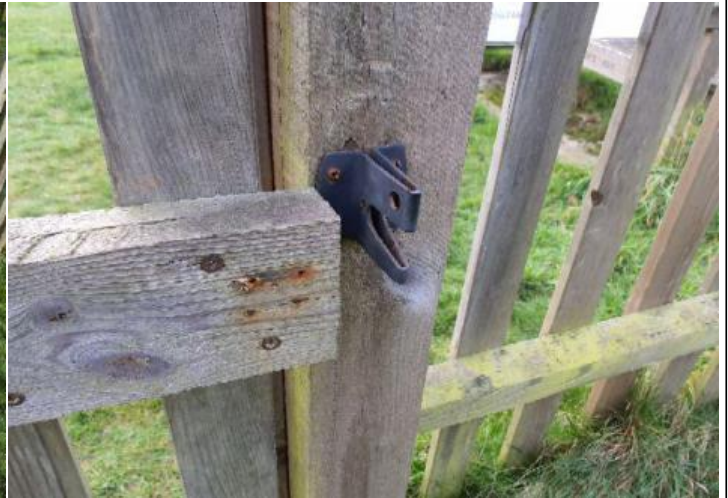
**Item:** Gates - Gate  
**Manufacturer:** Not Identified

**Finding:** The gate latch is damaged or missing

**Action:** Repair or replace

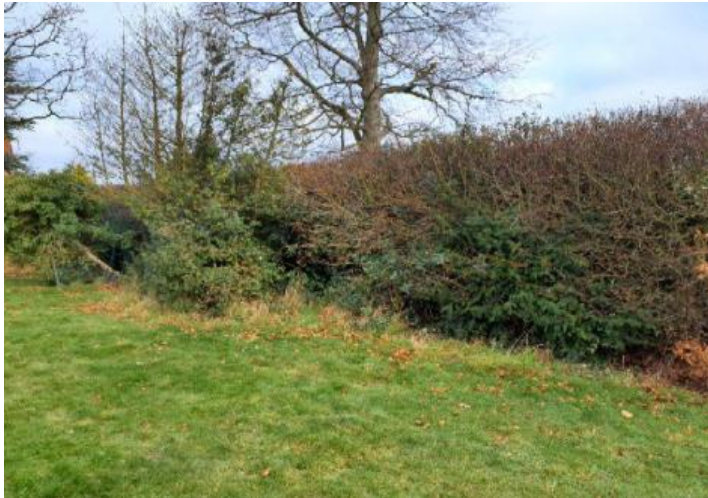
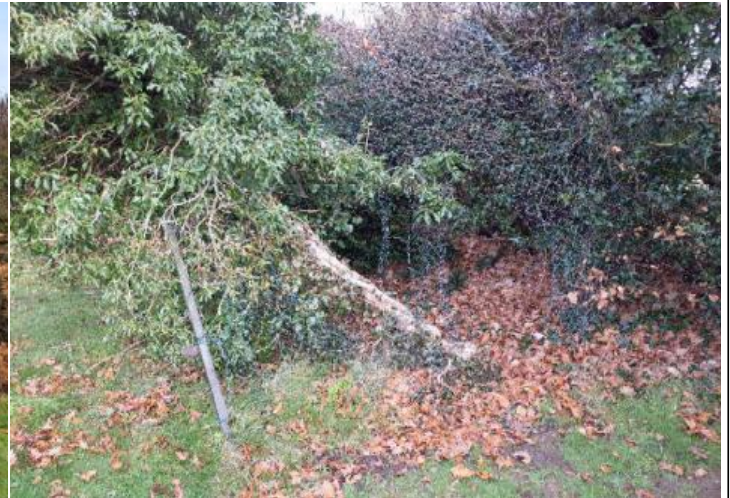
**Item:** Ancillary Items - Hedge  
**Manufacturer:** Natural Feature

**Finding:** The fence behind the hedge line is severely damaged

**Action:** Replace

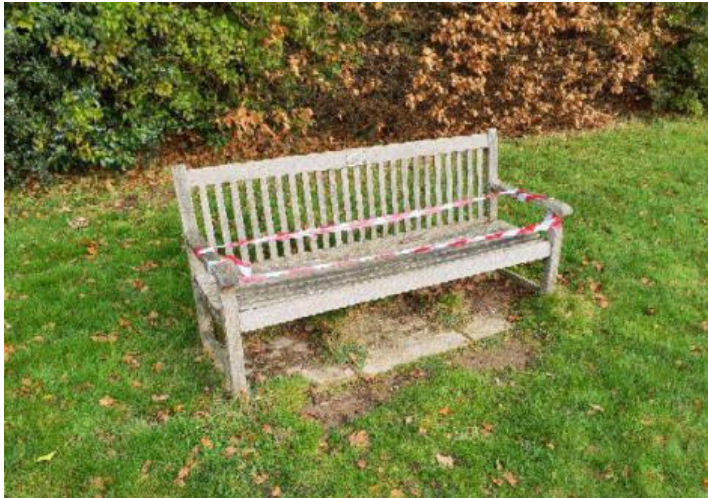
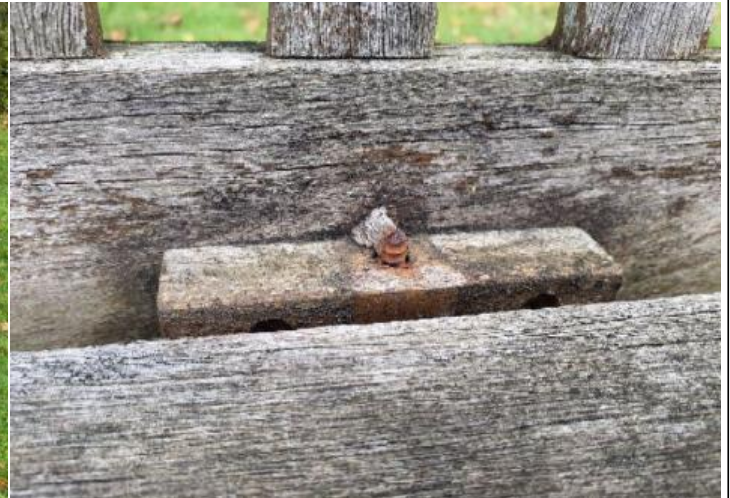
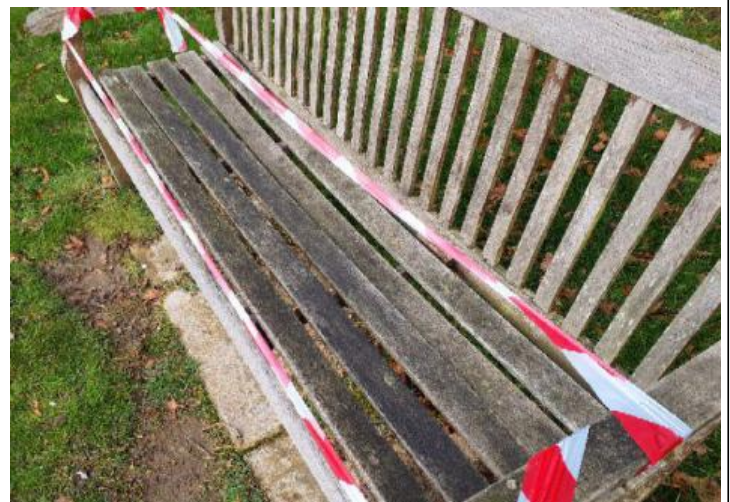
**Item:** Ancillary Items - Bench  
**Manufacturer:** Not Identified

**Finding:** There is some damage to the item and there are projecting screws preset

**Action:** Repair or replace

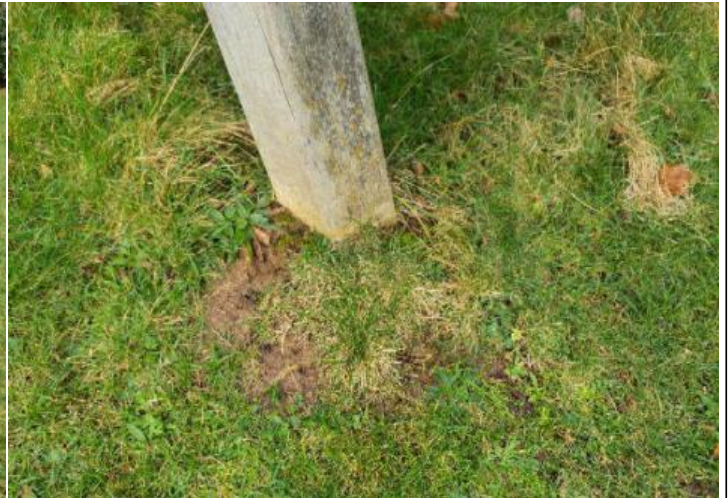
**Item:** Ancillary Items - Picnic Table  
**Manufacturer:** Not Identified

**Finding:** There is some strimmer / machinery damage apparent on the posts, this can penetrate the preservative applied to the timber and accelerate the rotting process

**Action:** Monitor for any deterioration (rot) and replace as required

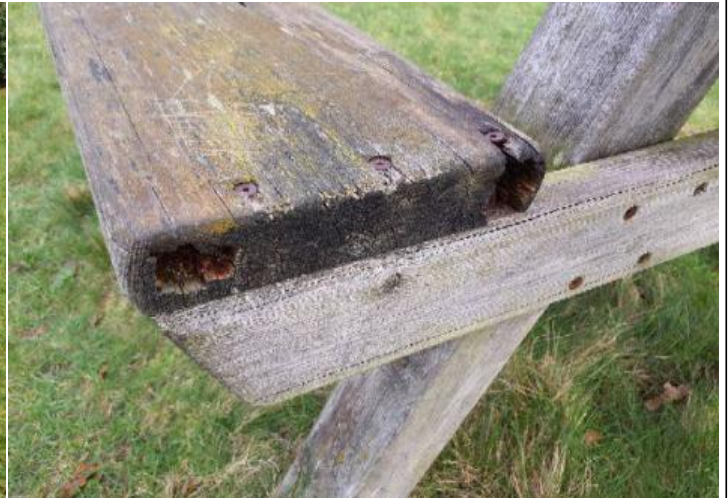
**Item:** Ancillary Items - Picnic Table  
**Manufacturer:** Not Identified

**Finding:** There is some evidence of rot in the timber

**Action:** Monitor for any further deterioration and replace as required

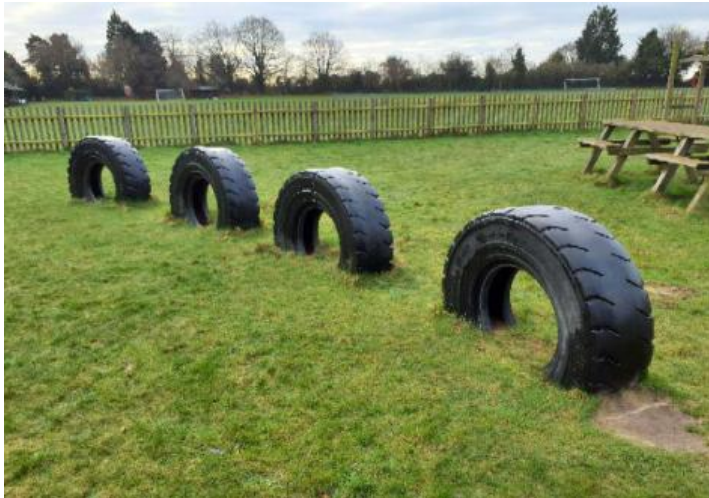
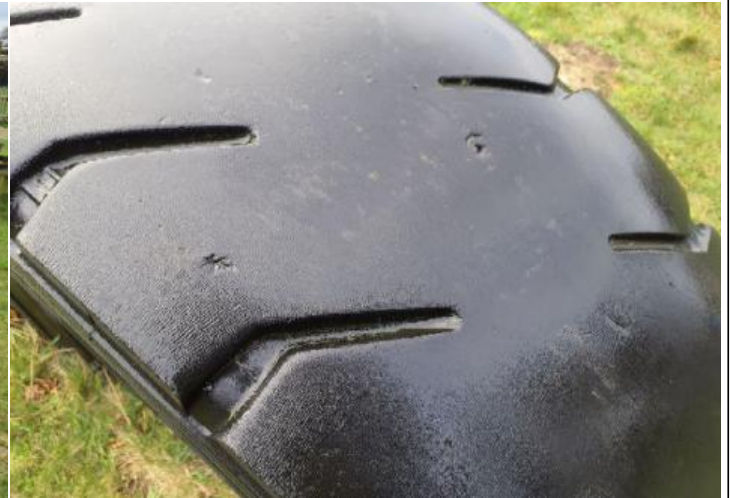
**Item:** Activity Equipment - Tyre Trail  
**Manufacturer:** Not Identified

**Finding:** There is some damage to the item

**Action:** Monitor for any further deterioration and repair as required

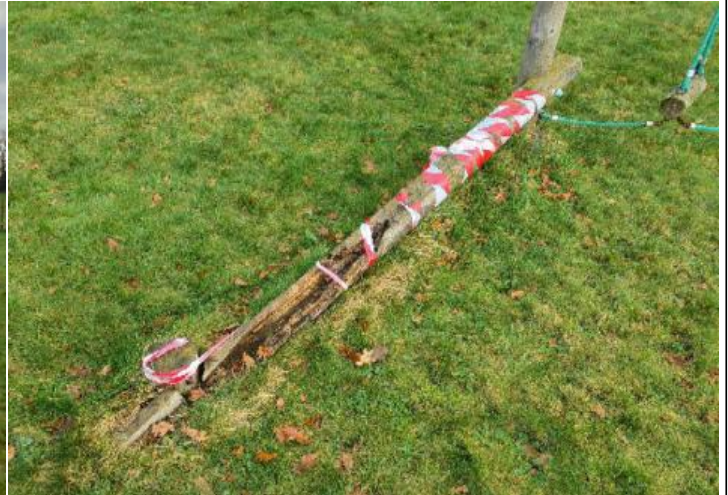
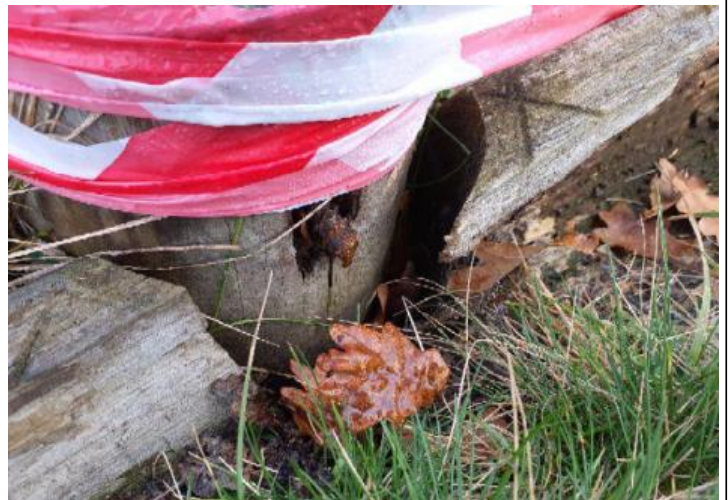
**Item:** Activity Equipment - Activity Trail  
**Manufacturer:** Adventure Playgrounds

**Finding:** The timber on this item has severe rot and there are protruding bolts present

**Action:** Remove and replace all affected timber sections

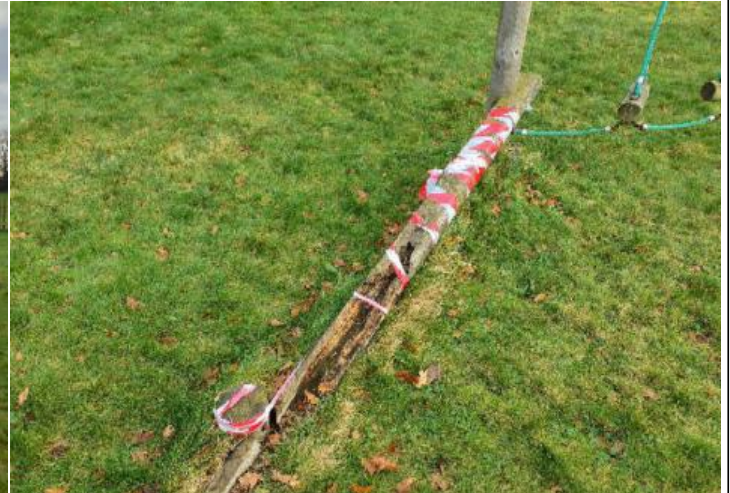
**Item:** Activity Equipment - Activity Trail  
**Manufacturer:** Adventure Playgrounds

**Finding:** The area / equipment on site has been isolated from use however the area is still accessible and the means of isolation has either introduced additional hazards that may cause harm in the event of users accessing the area or is insufficient to stop users from accessing the equipment

**Action:** Provide a more suitable isolation method

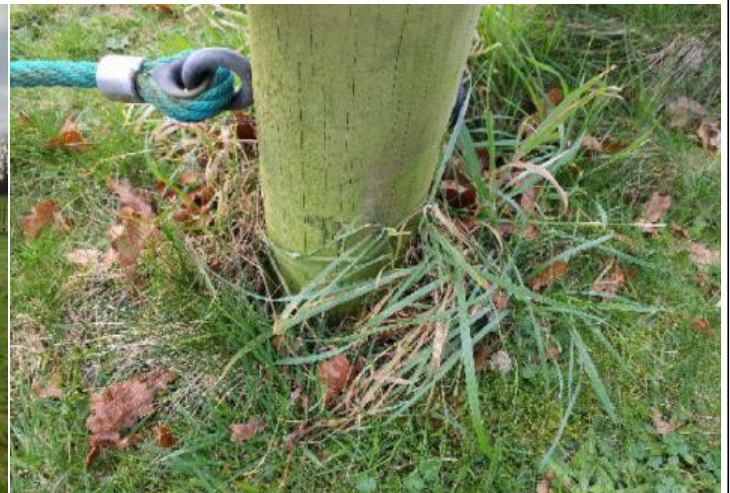
**Finding:** There is some strimmer / machinery damage apparent on the posts, this can penetrate the preservative applied to the timber and accelerate the rotting process

**Action:** Monitor for any deterioration (rot) and replace as required

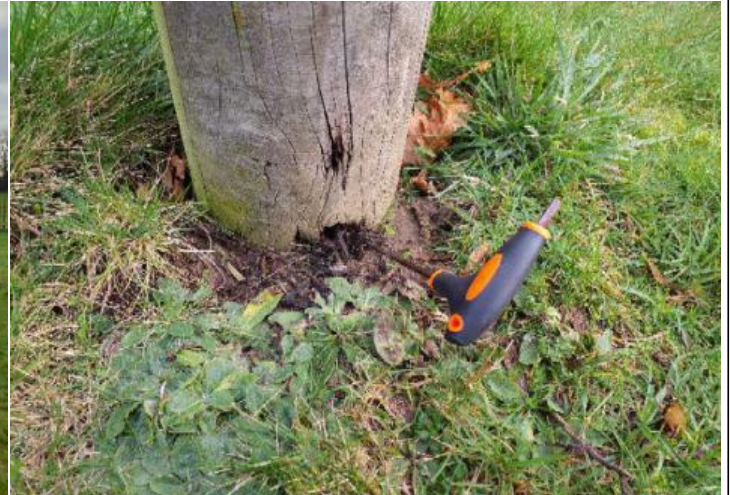
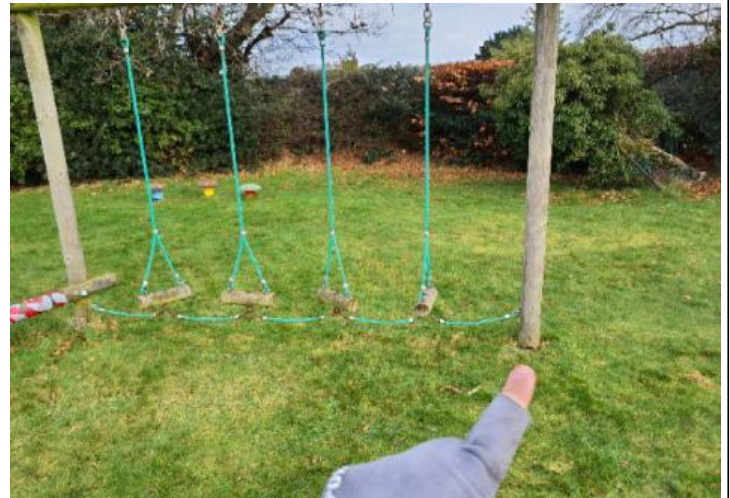
**Finding:** There are areas or parts of the timber on the structure that have rotted

**Action:** Replace all affected timbers

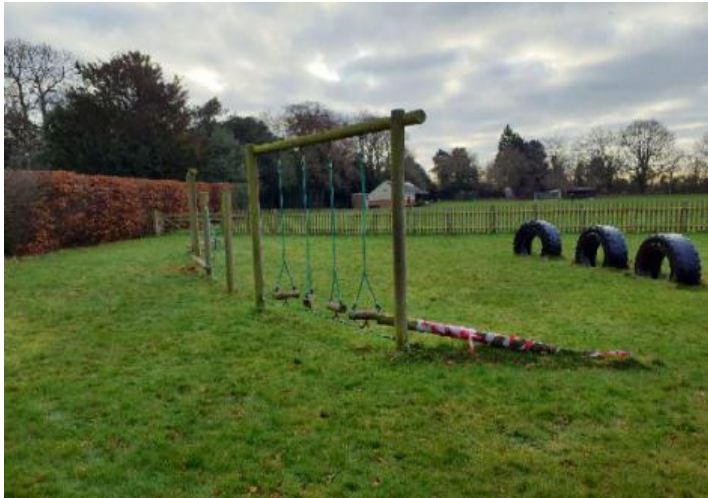
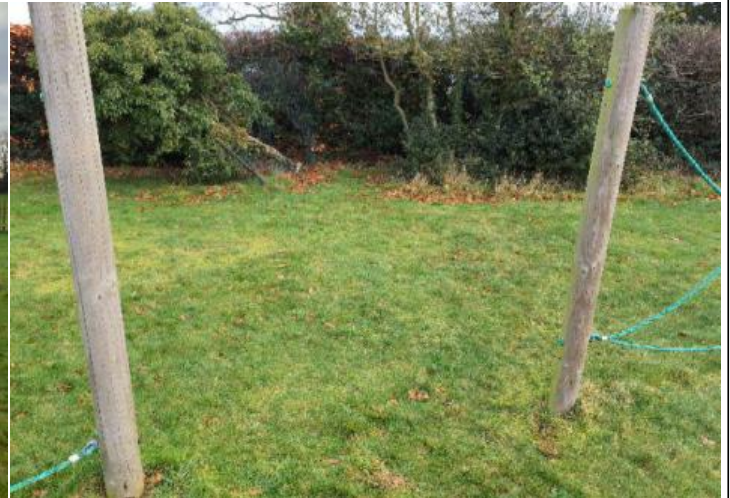
**Finding:** The item has missing component(s)

**Action:** Consider replacing missing components

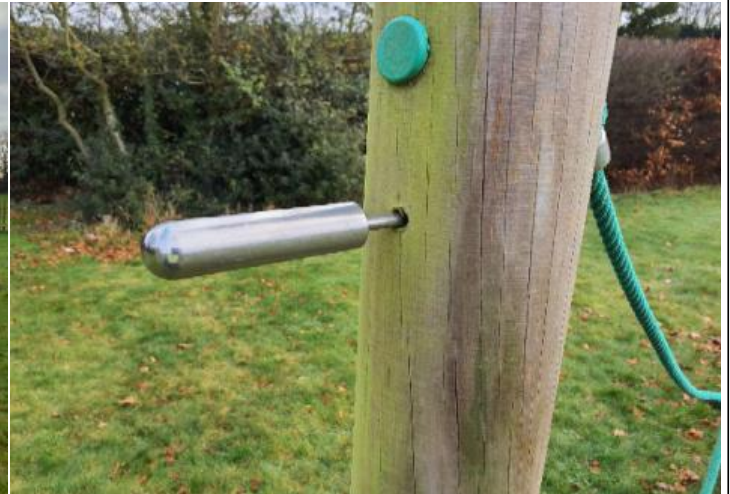
**Finding:** There is/are finger entrapment/s in the post due to missing components and the item fails to meet the requirements of BS EN 1176 Part 1 4.2.7.6 Entrapment of fingers

**Action:** Provide missing components to remove entrapment

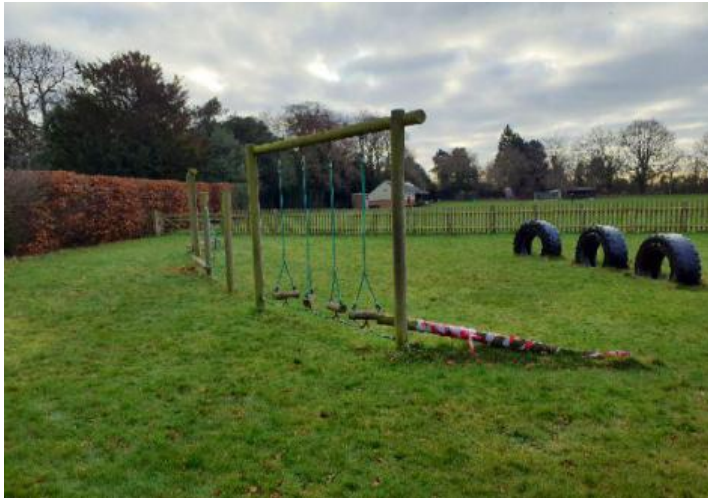
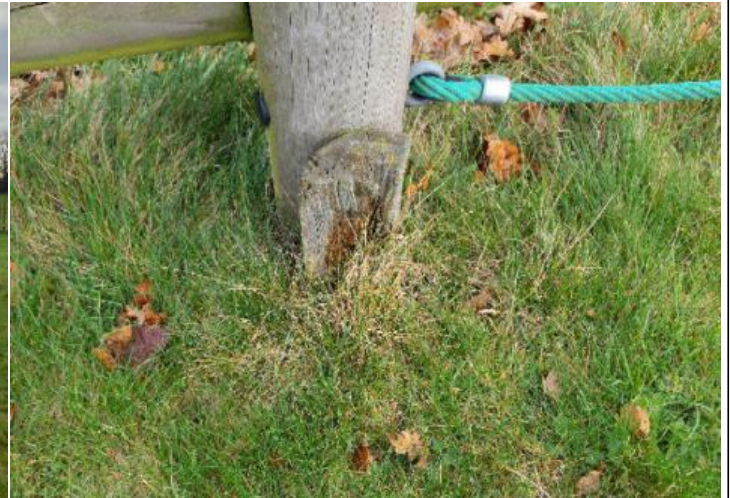
**Finding:** There are areas or parts of the timber on the structure that have rotted

**Action:** Replace all affected timbers

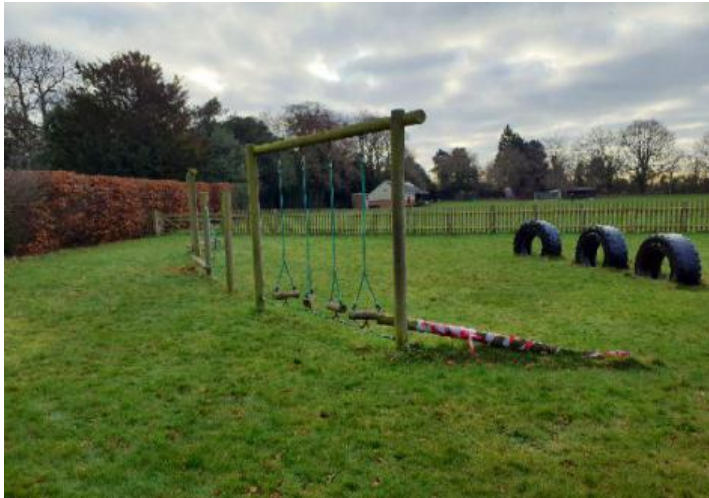
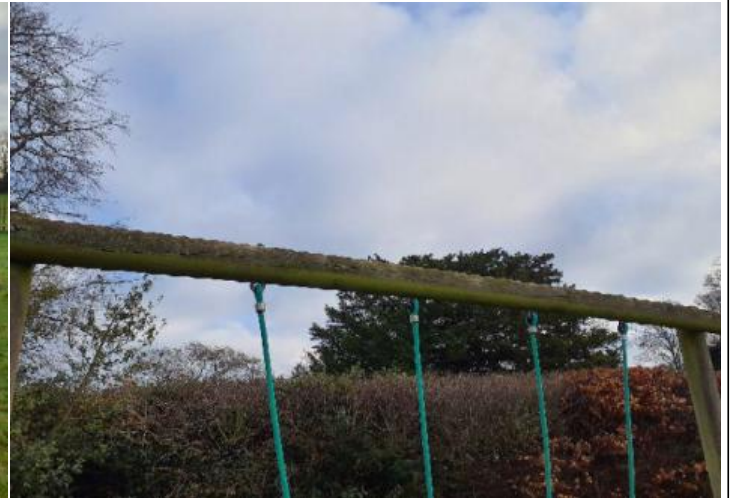
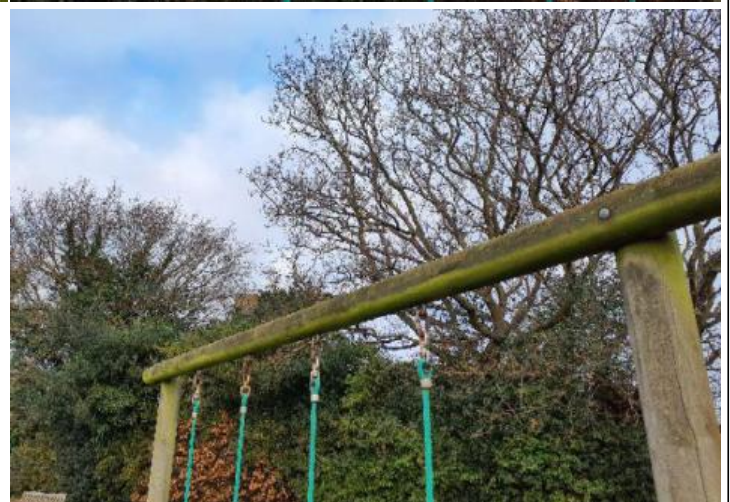
**Finding:** The inspector has some concerns about the internal condition of the timber crossbeams and was unable to verify the structural integrity without further testing. We recommend a Resi-PD survey to establish the condition of the timber at it's core.

**Action:** Contact the Play Inspection Company office for further information

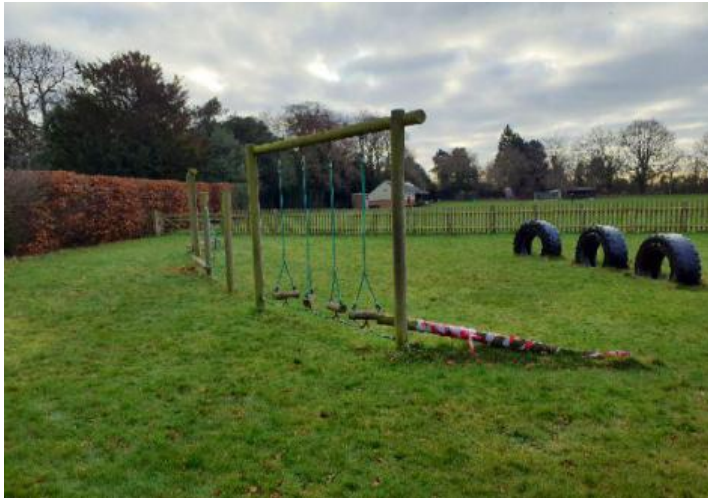
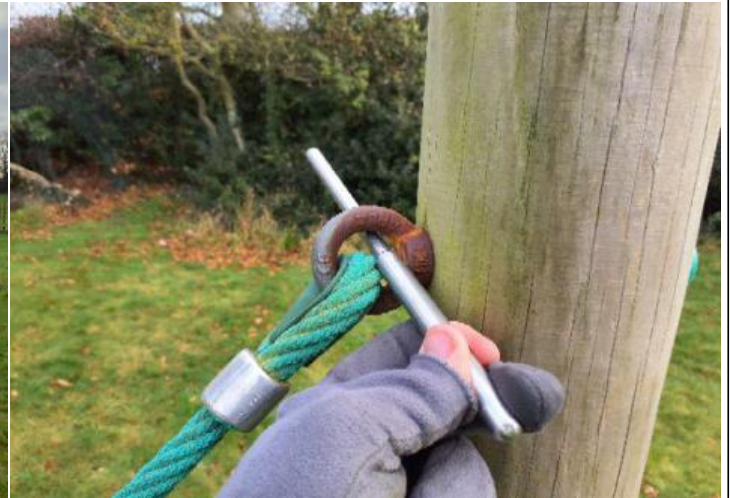
**Finding:** The connecting links are in excess of 8.6mm and less than 12mm and fail the requirements of BS EN 1176 Part 1; clause 4.2.13, Chains

**Action:** Monitor use and replace with compliant links at the next maintenance cycle

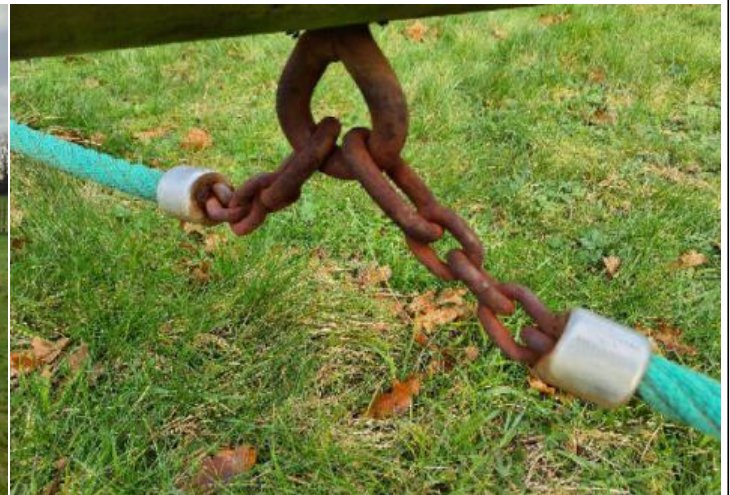
**Finding:** There is some notable evidence of chain wear

**Action:** Monitor for any further deterioration and replace when 40% worn

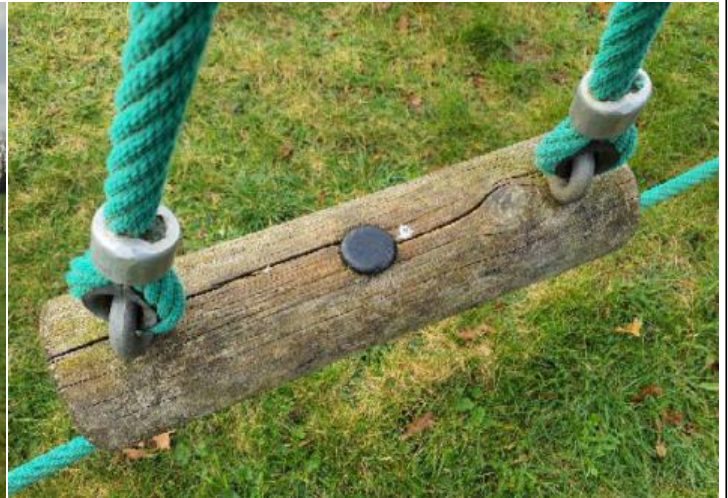
**Finding:** The timber has a number of splits/shakes or air cracks and this may affect the stability or allow water ingress which will accelerate the rotting process

**Action:** Monitor to ensure the splits do not cross through fixing points of the structure and/or cause any instability

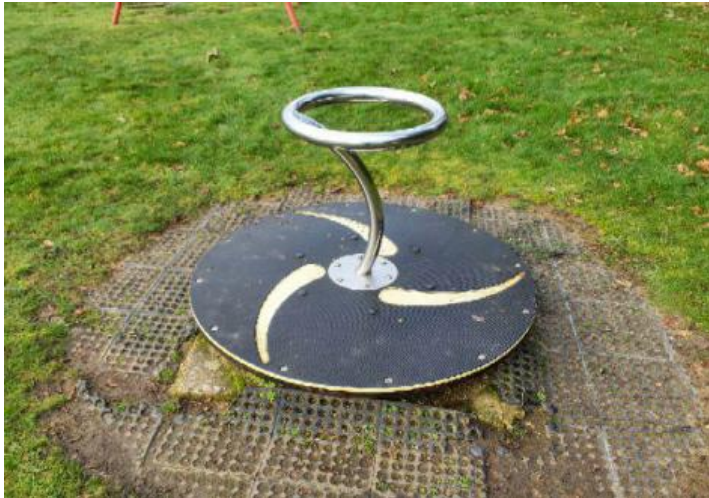
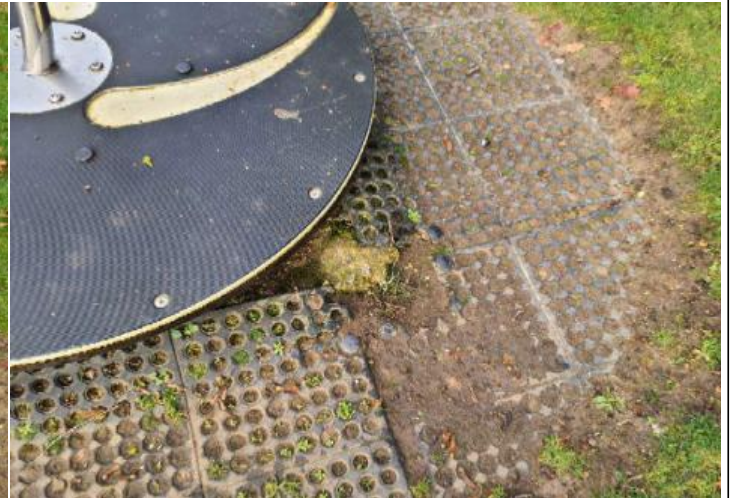
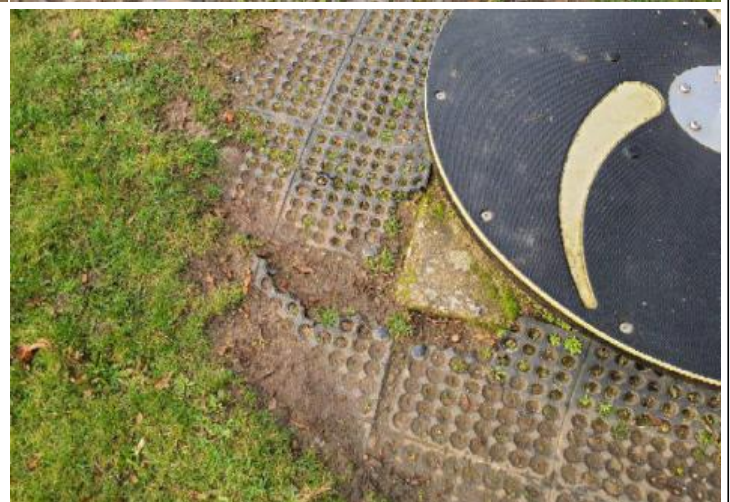
**Finding:** The surfacing is severely damaged

**Action:** Repair damaged areas of surfacing

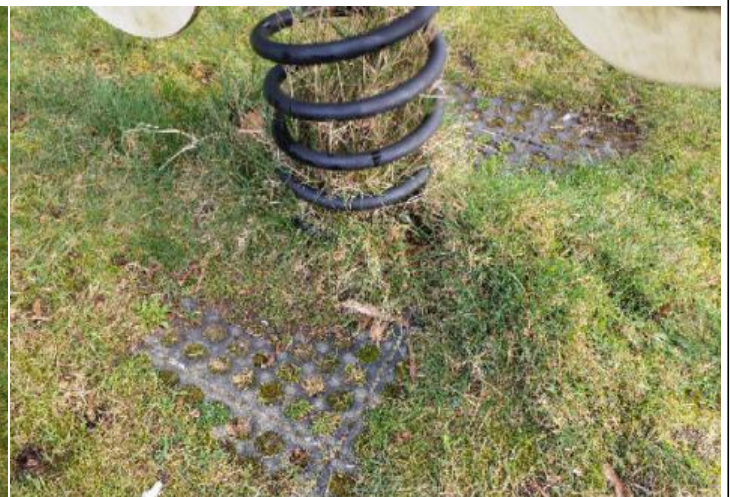
**Finding:** The item is slightly loose in its foundations

**Action:** Monitor for any further deterioration and repair as required

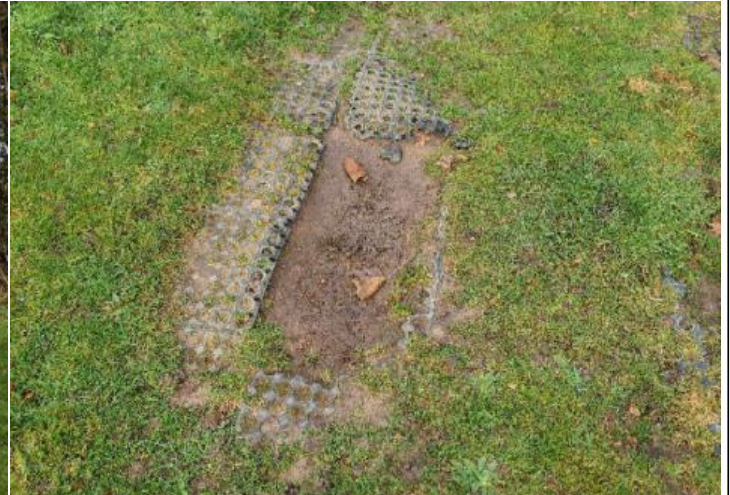
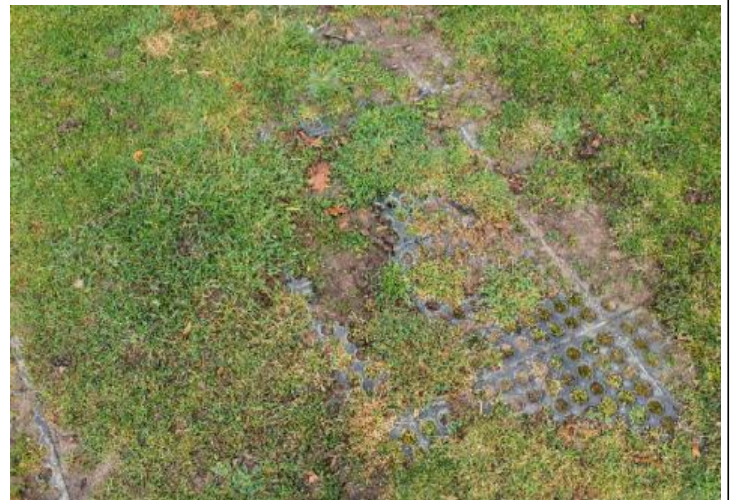
**Finding:** There is moderate damage to the surface

**Action:** Repair the damaged areas of surfacing

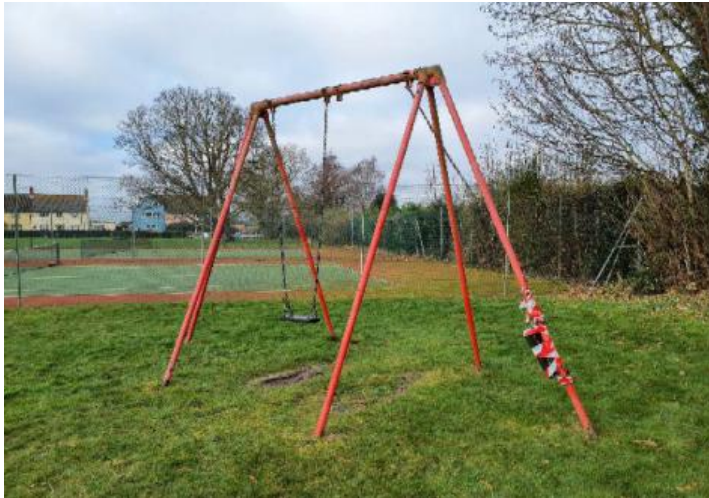
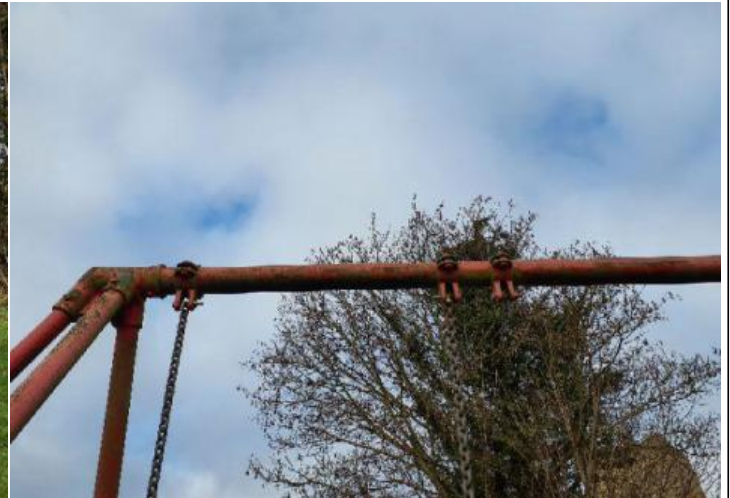
**Finding:** The fixings or components for this item were in excess of 2.5m above the standing surface and could not be fully accessed by the inspector. We have completed a visual inspection of the fixings from ground level but a maintenance inspection should be undertaken to assess the condition, security and wear of the components at intervals in accordance with the manufacturers recommendations.

**Action:** Inspect in accordance with the manufacturers recommendations

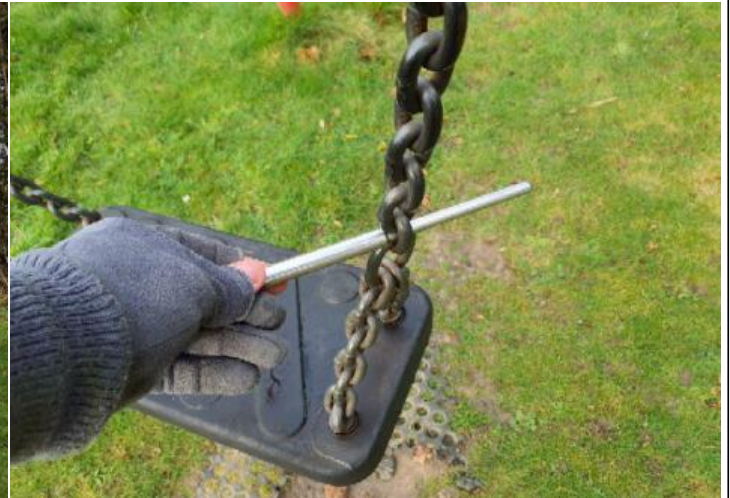
**Finding:** The chain openings are in excess of 8.6mm and do not meet the recommendations of BS EN 1176 Part 1

**Action:** Monitor - No remedial work recommended

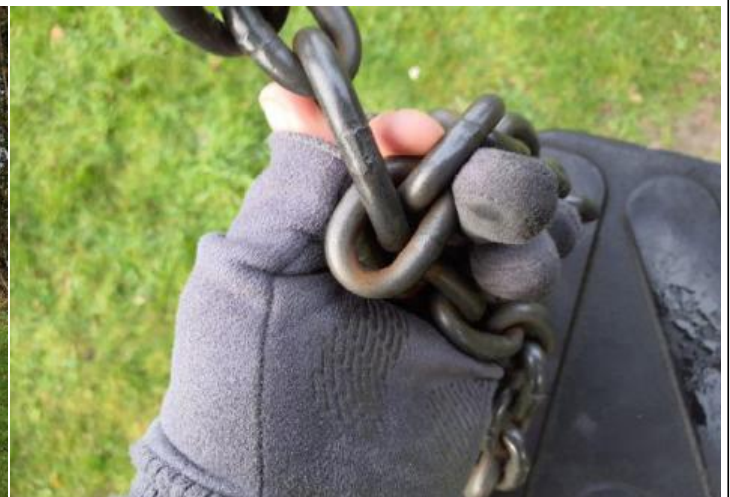
**Finding:** There is some notable evidence of chain wear

**Action:** Monitor for any further deterioration and replace when 40% worn

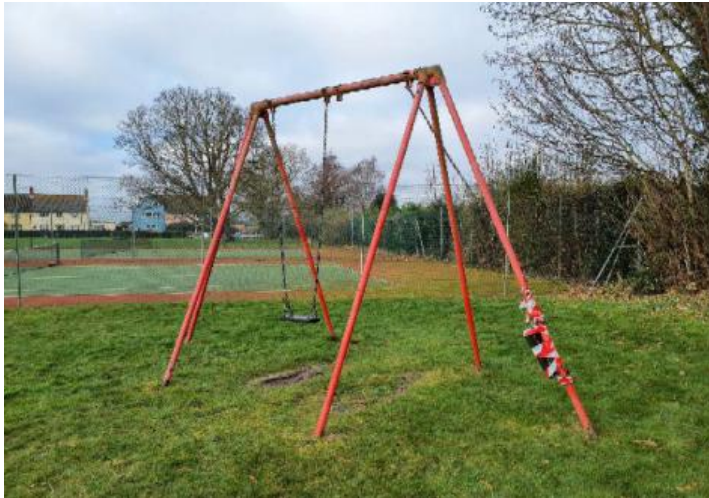
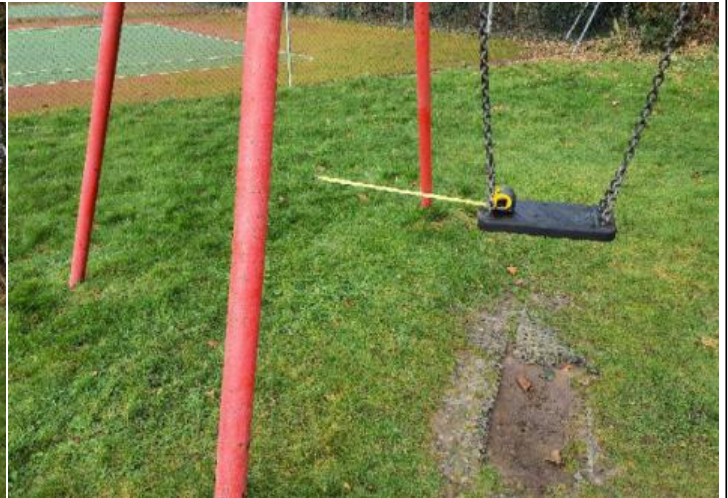
**Finding:** The seats are too close to the frame as defined in BS EN 1176 Part 2; this is a low risk failure and no remedial action is required

**Action:** Monitor - No remedial work recommended

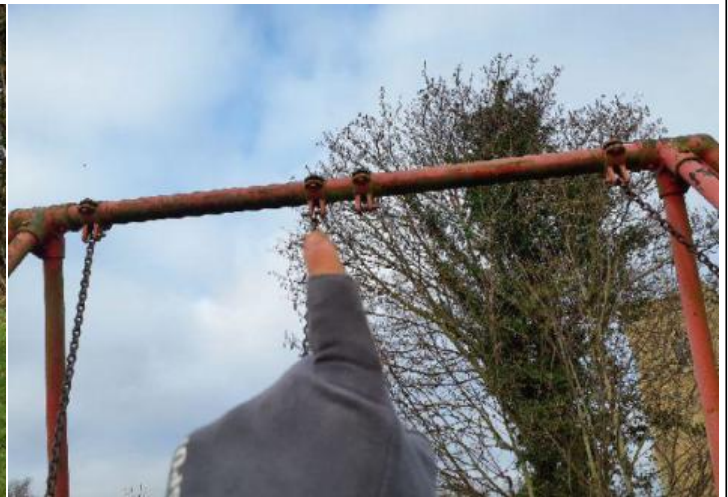
**Finding:** The connecting pin is showing signs of wear

**Action:** Monitor for any further deterioration and replace as required

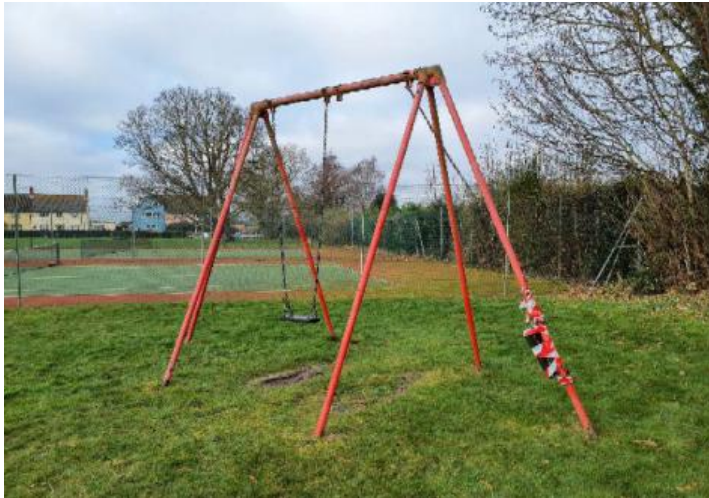
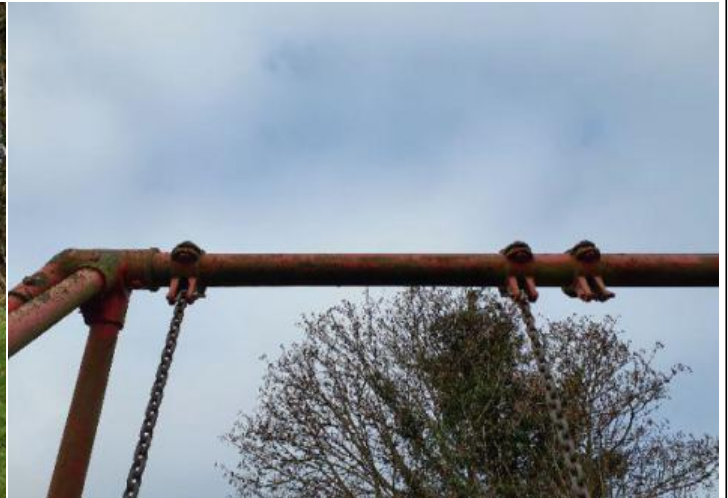
**Finding:** There is some wear to the shackles

**Action:** Monitor for any further deterioration and replace when 40% worn

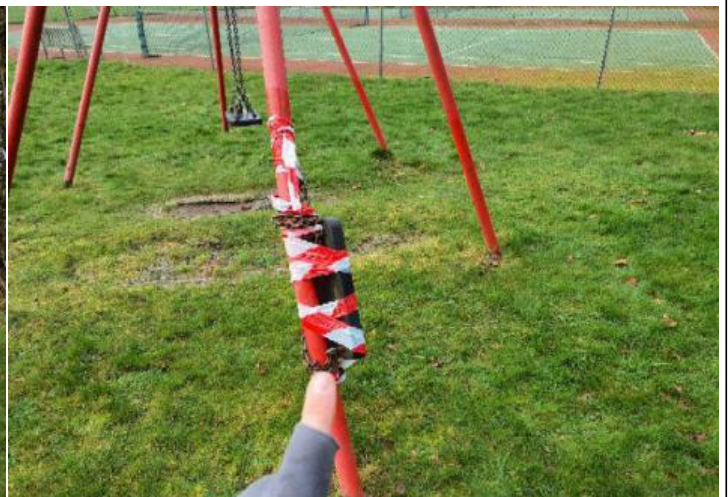
**Finding:** There is minor distortion damage to one of the legs **Action:** Monitor for any further deterioration and repair or replace as required

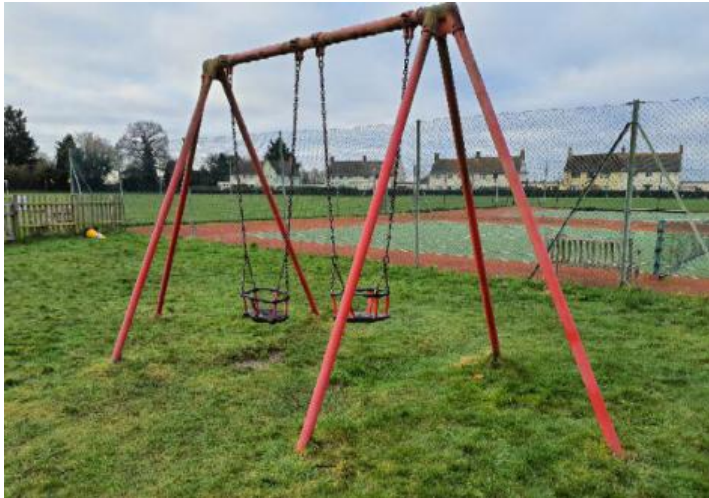
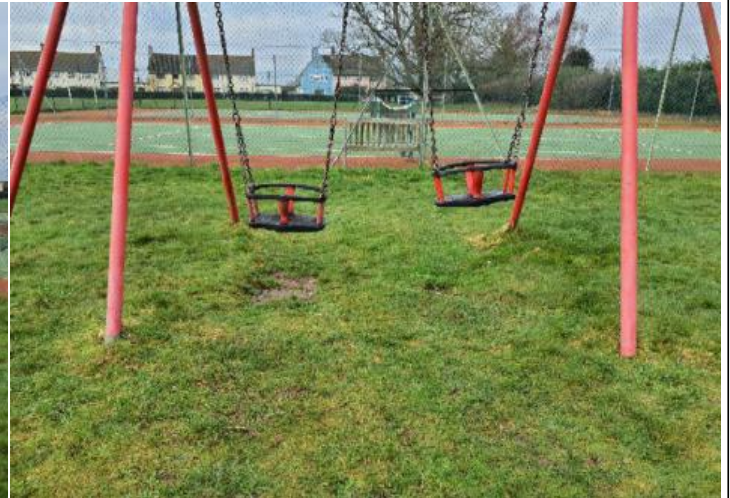
**Finding:** The seats are not level at rest

**Action:** Adjust seat to prevent accelerated chain wear

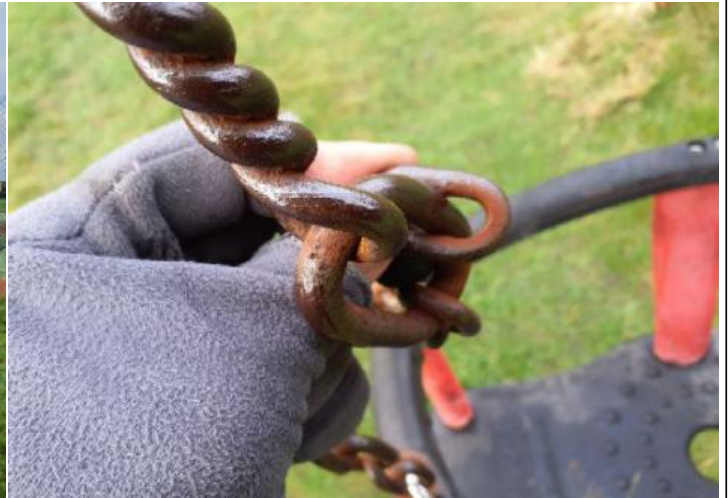
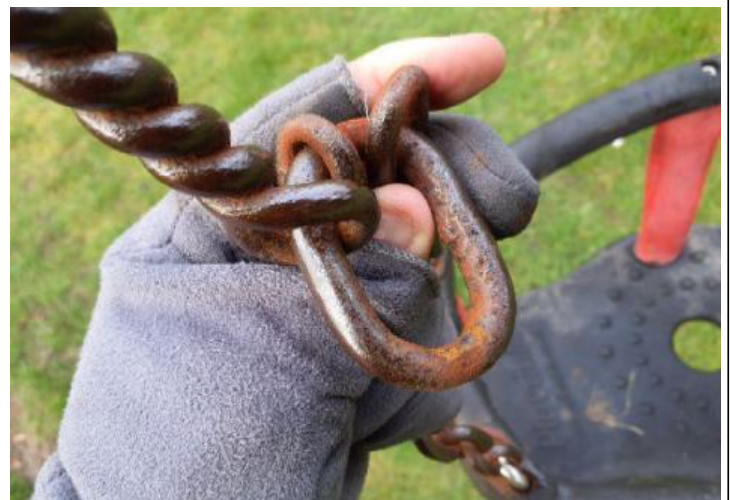
**Finding:** There is some notable evidence of chain wear

**Action:** Monitor for any further deterioration and replace when 40% worn

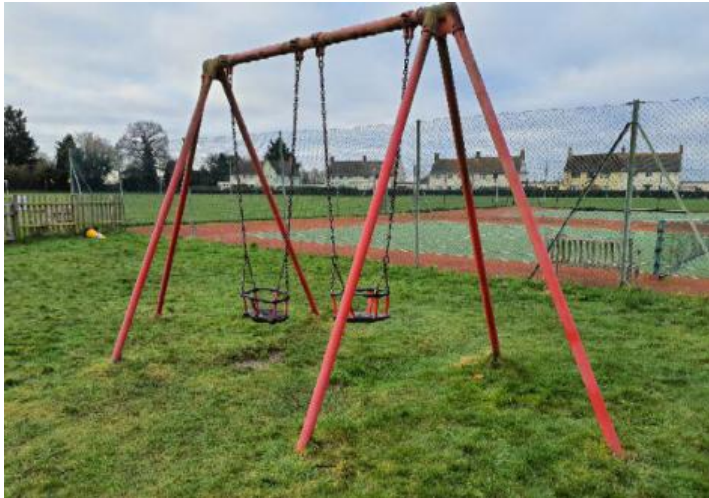
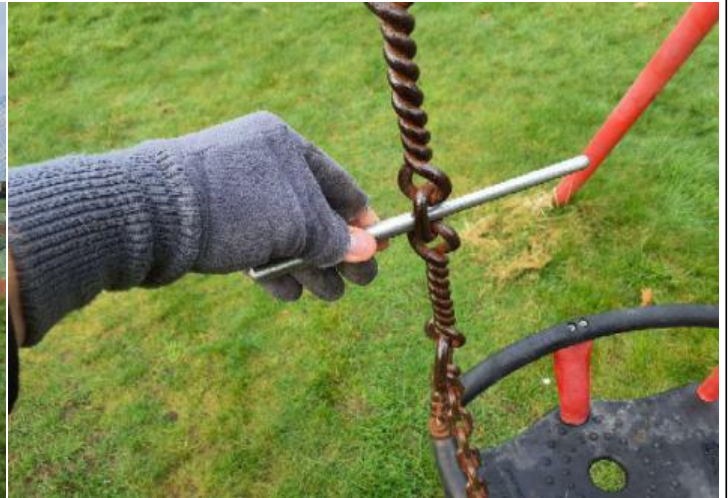
**Finding:** The chain openings are in excess of 8.6mm and do not meet the recommendations of BS EN 1176 Part 1

**Action:** Monitor - No remedial work recommended

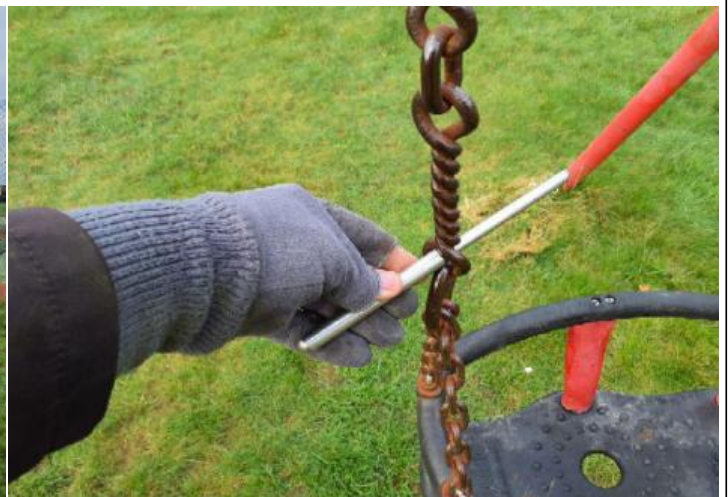
**Finding:** The connecting links are in excess of 8.6mm and less than 12mm and fail the requirements of BS EN 1176 Part 1; clause 4.2.13, Chains

**Action:** Monitor use and replace with compliant links at the next maintenance cycle

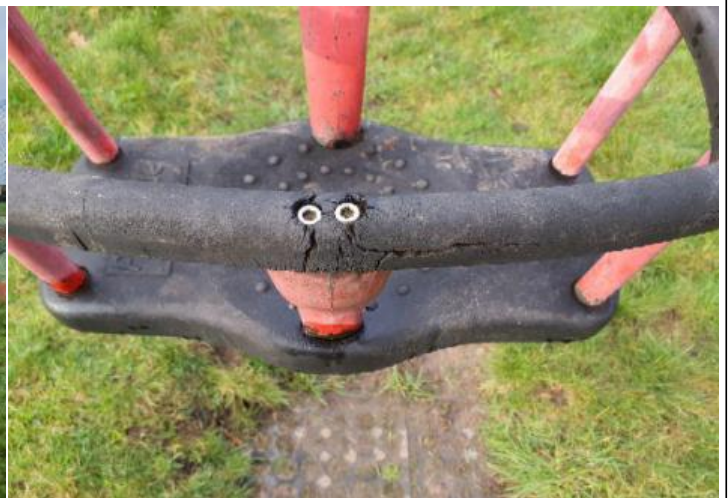
**Finding:** The seat has minor damage or wear

**Action:** Monitor for any further deterioration and replace as required

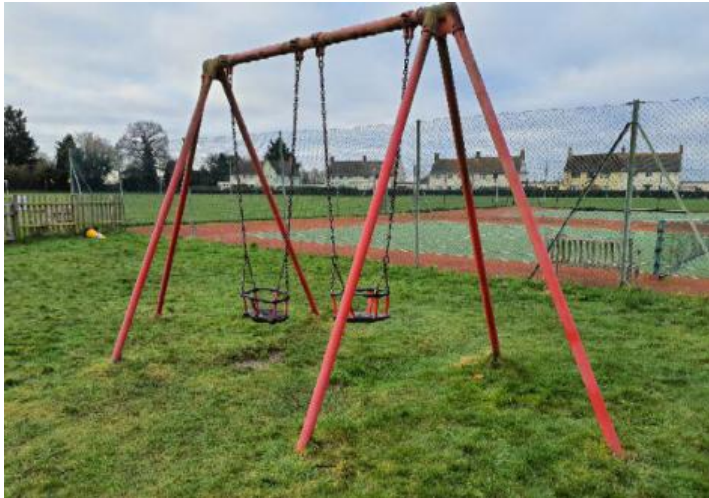
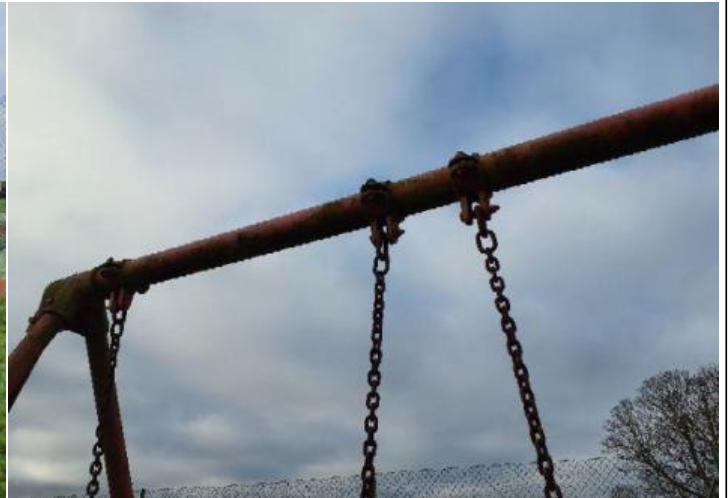
**Finding:** The connecting pins are showing signs of wear

**Action:** Monitor for any further deterioration and replace as required

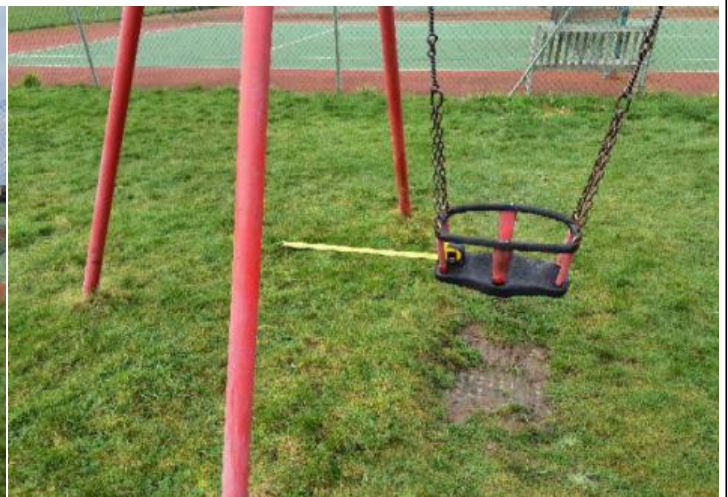
**Finding:** The seats are too close to the frame as defined in BS EN 1176 Part 2; this is a low risk failure and no remedial action is required

**Action:** Monitor - No remedial work recommended
