# TATTINGSTONE

Paper submitted by the Clerk to the Council at the Parish Council meeting on 04 March 2024

### Parish Clerk's Report – March 2024

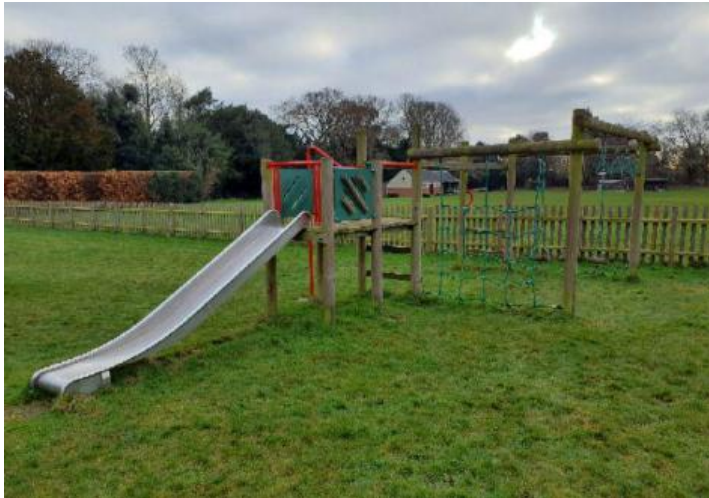
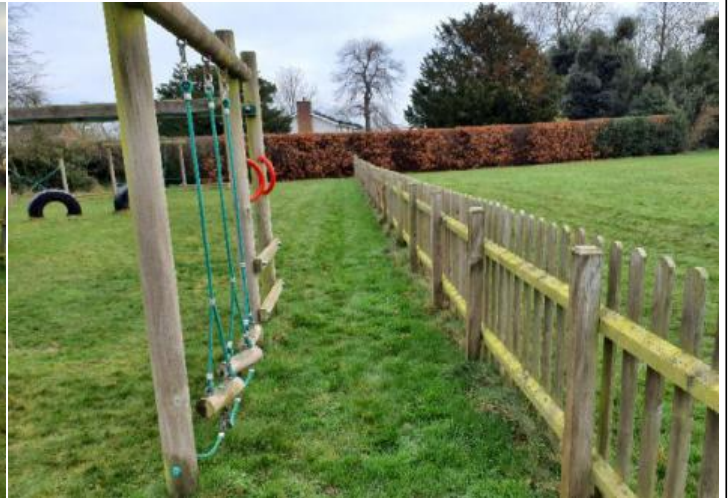
**Finding:** The fence forms a hard object within the falling space of the equipment and there is also insufficient surfacing provided in contravention of BS EN 1176 Part 1

**Action:** Monitor - no remedial work recommended

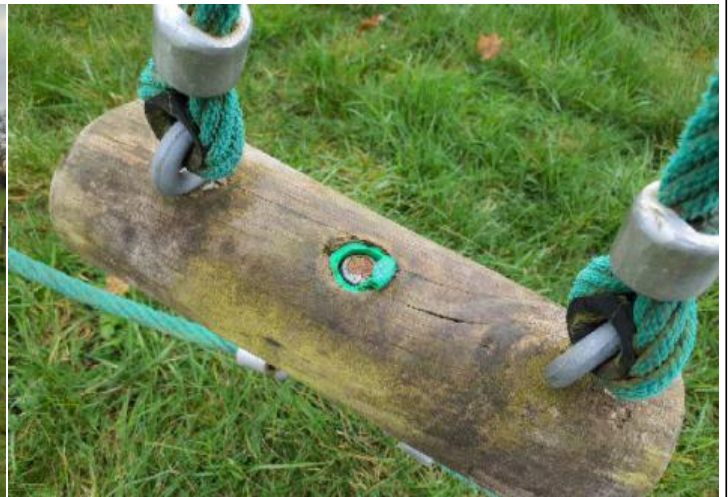
**Finding:** There is/are bolt cap covers missing or damaged on the item

**Action:** Replace missing or damaged bolt cap covers

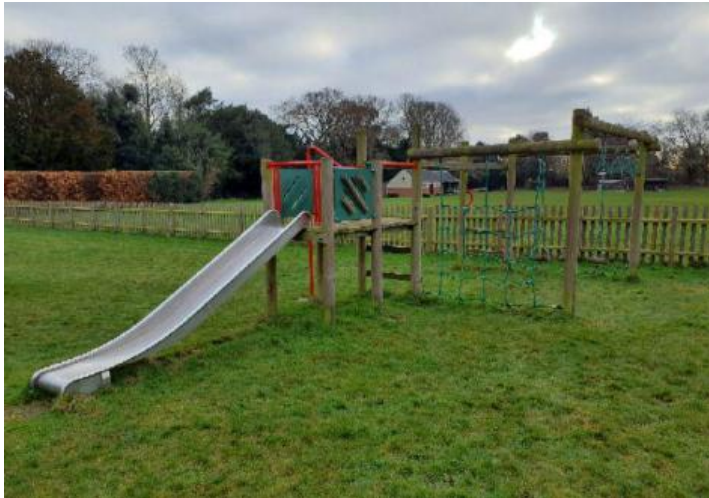
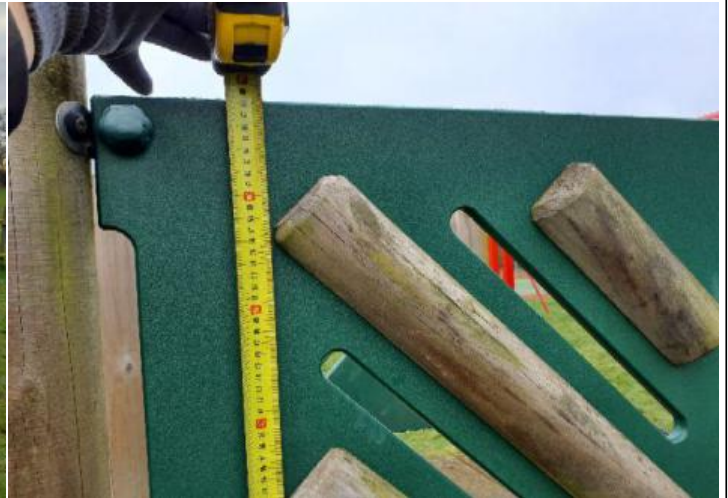
**Finding:** The height of the barrier(s) is insufficient and fails to meet the requirements of BS EN 1176 Part 1

**Action:** Monitor - No remedial work recommended

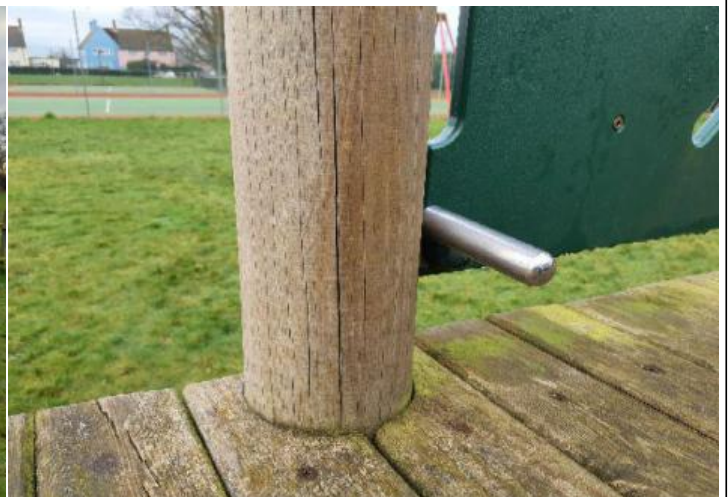
**Finding:** There is/are finger entrapment/s in the barrier and the item fails to meet the requirements of BS EN 1176 Part 1 4.2.7.6 Entrapment of fingers

**Action:** Monitor - No remedial work recommended

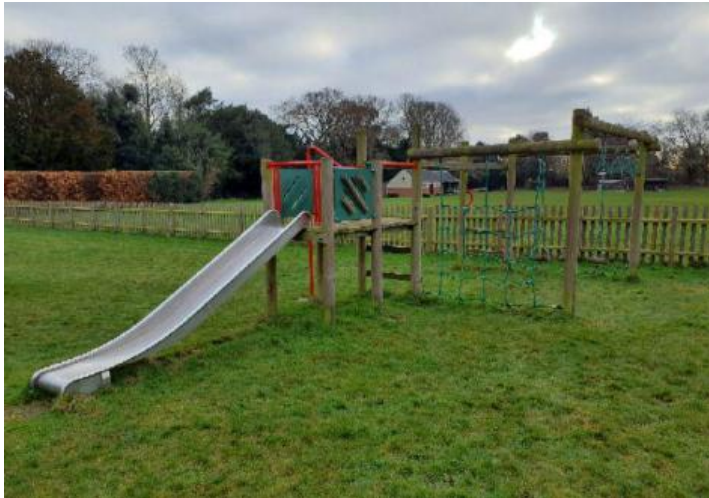
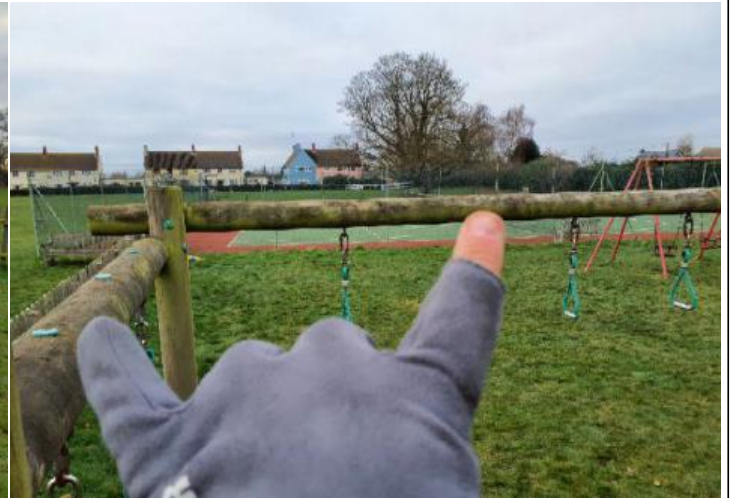
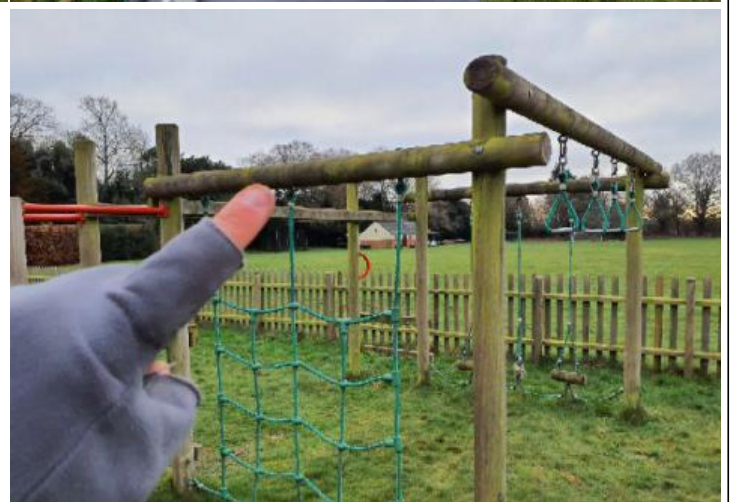
**Finding:** The inspector has some concerns about the internal condition of the timber crossbeams and was unable to verify the structural integrity without further testing. We recommend a Resi-PD survey to establish the condition of the timber at it's core.

**Action:** Contact the Play Inspection Company office for further information

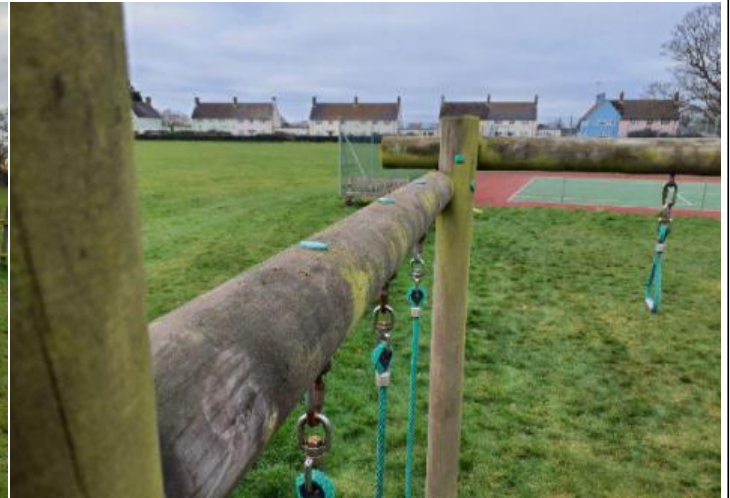
**Finding:** There is some evidence of rot in the timber

**Action:** Monitor for any further deterioration and replace as required

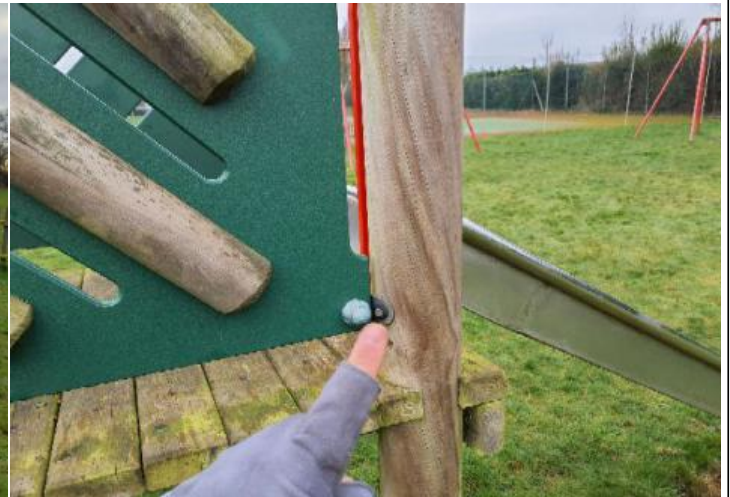
**Finding:** A number of fixing(s) have worked loose

**Action:** Secure all loose fixings

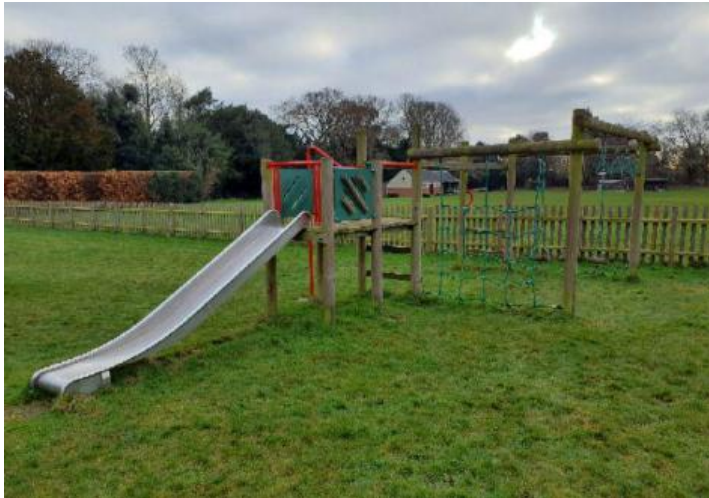
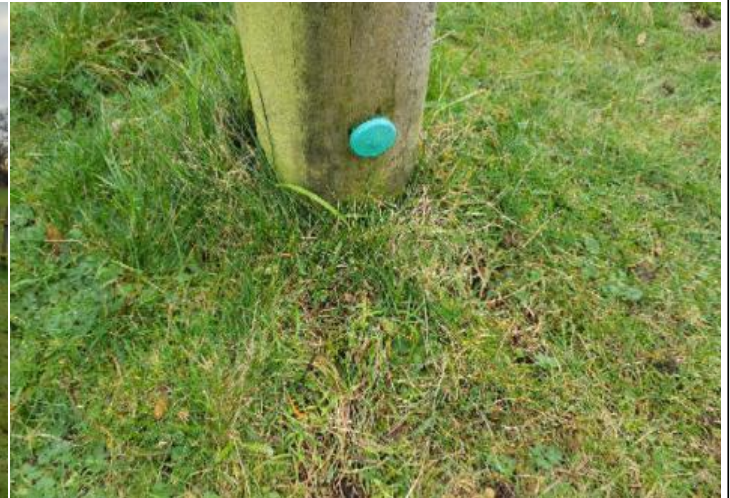
**Finding:** There is some strimmer / machinery damage apparent on the posts, this can penetrate the preservative applied to the timber and accelerate the rotting process

**Action:** Monitor for any deterioration (rot) and replace as required
