# TATTINGSTONE

Paper submitted by the Clerk to the Council at the Parish Council meeting on 04 March 2024

### Parish Clerk's Report – March 2024

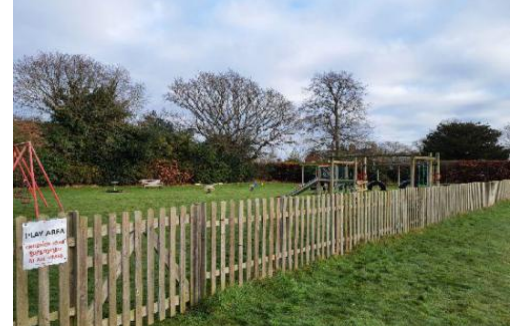
**Item:** Site General  
**Manufacturer:** Owner/Operator  
**Surface Type:** N/A  
**Item Quantity:** 1  
**Equipment Compliance:** N/A  
**Surface Area Compliance:** N/A

NOTE - The client was made aware of any findings with a risk score of 15 and above at the time of the inspection, due to the urgency of action required. - Ensure appropriate action is, or has already been taken.

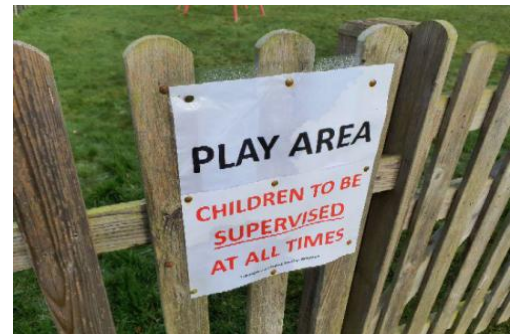
**Item:** Sign  
**Manufacturer:** Owner/Operator  
**Surface Type:** N/A  
**Item Quantity:** 1  
**Equipment Compliance:** N/A  
**Surface Area Compliance:** N/A

It is recommended that signage, with information including the site address, contact information for maintenance issues and emergency contact details are provided for the facility - Provide in accordance with the recommendations

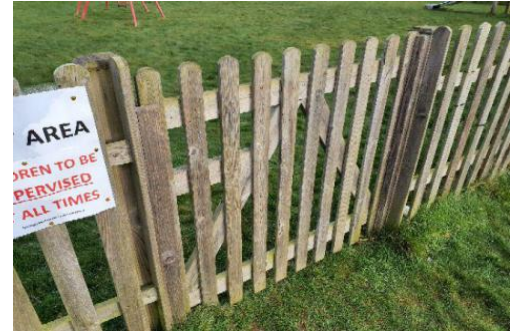
**Item:** Gate  
**Manufacturer:** Not Identified  
**Surface Type:** Grass  
**Item Quantity:** 1  
**Equipment Compliance:** N/A  
**Surface Area Compliance:** N/A

There are openings that are less than 12mm that could trap or crush fingers - Provide a 12mm gap throughout full range of motion at both sides of gate

The gate latch is damaged or missing - Repair or replace

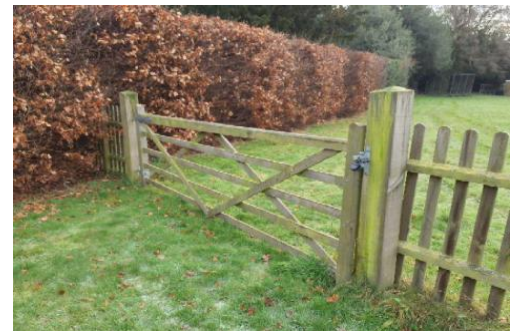
**Item:** Gate - Maintenance  
**Manufacturer:** Not Identified  
**Surface Type:** Grass  
**Item Quantity:** 1  
**Equipment Compliance:** N/A  
**Surface Area Compliance:** N/A

The maintenance gate was correctly padlocked at the time of inspection, however this means that the inspector was unable to fully assess the gate - Ensure that there are 12mm gaps throughout the full range of motion on gate/s and between leaves where relevant

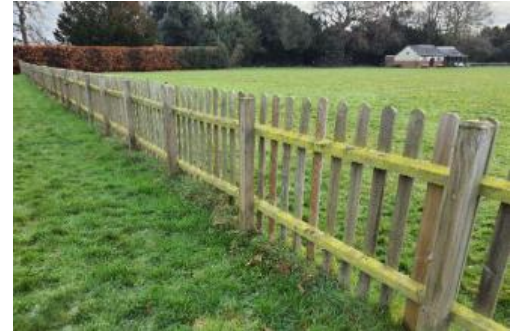
**Item:** Fencing - Timber  
**Manufacturer:** Not Identified  
**Surface Type:** Grass  
**Item Quantity:** 1  
**Equipment Compliance:** N/A  
**Surface Area Compliance:** N/A

This item is satisfactory - no work required -

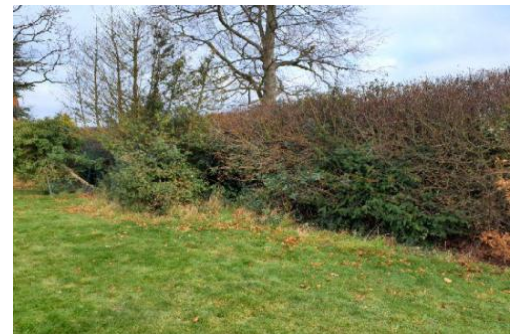
**Item:** Hedge  
**Manufacturer:** Natural Feature  
**Surface Type:** N/A  
**Item Quantity:** 1  
**Equipment Compliance:** N/A  
**Surface Area Compliance:** N/A

The fence behind the hedge line is severely damaged - Replace

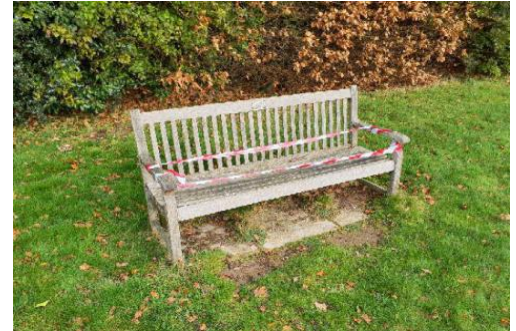
**Item:** Bench  
**Manufacturer:** Not Identified  
**Surface Type:** Grass  
**Item Quantity:** 2  
**Equipment Compliance:** N/A  
**Surface Area Compliance:** N/A

There is some damage to the item and there are projecting screws preset - Repair or replace

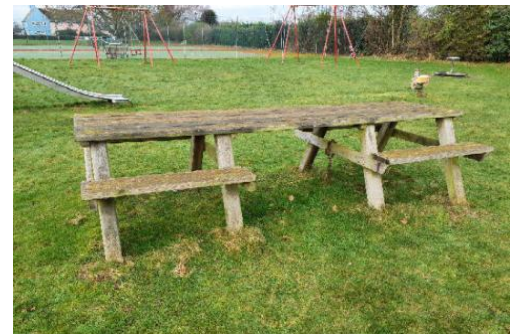
**Item:** Picnic Table  
**Manufacturer:** Not Identified  
**Surface Type:** Grass  
**Item Quantity:** 1  
**Equipment Compliance:** N/A  
**Surface Area Compliance:** N/A

There is some strimmer / machinery damage apparent on the posts, this can penetrate the preservative applied to the timber and accelerate the rotting process - Monitor for any deterioration (rot) and replace as required

There is some evidence of rot in the timber - Monitor for any further deterioration and replace as required

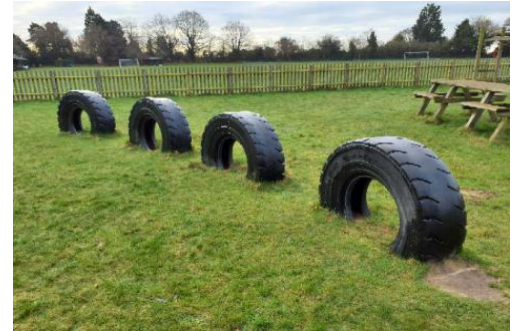
**Item:** Tyre Trail  
**Manufacturer:** Not Identified  
**Surface Type:** Grass  
**Item Quantity:** 1  
**Equipment Compliance:** Yes  
**Surface Area Compliance:** Yes

The grass has eroded within the impact area of the equipment and may not provide the necessary impact attenuating properties for the equipment fall height; the surface may also be slippery in wet weather - Reinstate the grass or provide an all weather surface

There is some damage to the item - Monitor for any further deterioration and repair as required

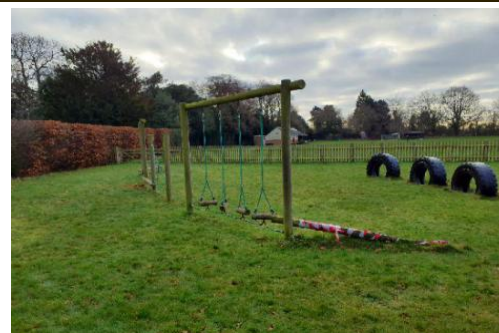
**Item:** Activity Trail  
**Manufacturer:** Adventure Playgrounds  
**Surface Type:** Grass  
**Item Quantity:** 1  
**Equipment Compliance:** No  
**Surface Area Compliance:** Yes

The timber on this item has severe rot and there are protruding bolts present - Remove and replace all affected timber sections

There is some strimmer / machinery damage apparent on the posts, this can penetrate the preservative applied to the timber and accelerate the rotting process - Monitor for any deterioration (rot) and replace as required

The item has missing component(s) - Consider replacing missing components

There are areas or parts of the timber on the structure that have rotted - Replace all affected timbers

The connecting links are in excess of 8.6mm and less than 12mm and fail the requirements of BS EN 1176 Part 1; clause 4.2.13, Chains - Monitor use and replace with compliant links at the next maintenance cycle

The area / equipment on site has been isolated from use however the area is still accessible and the means of isolation has either introduced additional hazards that may cause harm in the event of users accessing the area or is insufficient to stop users from accessing the equipment - Provide a more suitable isolation method

There is/are finger entrapment/s in the post due to missing components and the item fails to meet the requirements of BS EN 1176 Part 1 4.2.7.6 Entrapment of fingers - Provide missing components to remove entrapment

The inspector has some concerns about the internal condition of the timber crossbeams and was unable to verify the structural integrity without further testing. We recommend a Resi-PD survey to establish the condition of the timber at it's core. - Contact the Play Inspection Company office for further information

There is some notable evidence of chain wear - Monitor for any further deterioration and replace when 40% worn

The timber has a number of splits/shakes or air cracks and this may affect the stability or allow water ingress which will accelerate the rotting process - Monitor to ensure the splits do not cross through fixing points of the structure and/or cause any instability

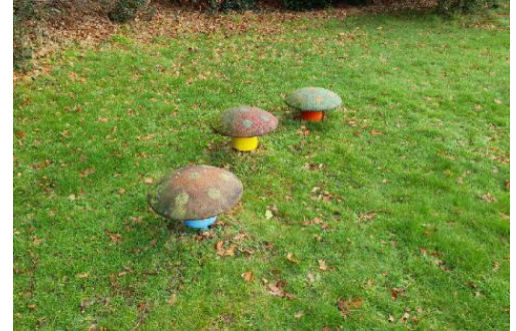
**Item:** Toadstools  
**Manufacturer:** Not Identified  
**Surface Type:** Grass  
**Item Quantity:** 1  
**Equipment Compliance:** Yes  
**Surface Area Compliance:** Yes

There is algae or moss on the surface of the equipment - Clean and treat appropriately

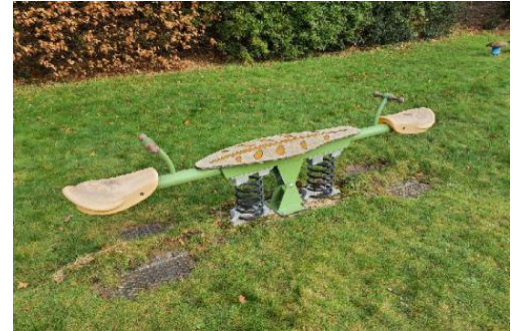
**Item:** Spring See-Saw  
**Manufacturer:** Husson UK  
**Surface Type:** Grass Matrix Tiles  
**Item Quantity:** 1  
**Equipment Compliance:** Yes  
**Surface Area Compliance:** No

The grass mats are silted up and the soil is compacted; this may have an effect on the impact absorbing properties of the surface. Consideration should be given to HIC testing the surface to verify impact attenuating properties ( <https://playinspections.co.uk/inspection-services/safety-surface-testing/> ) - Contact our office for a quotation for this service

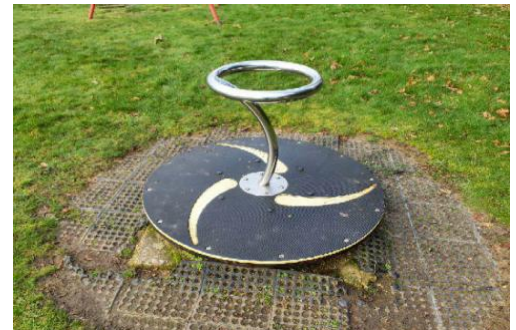
**Item:** Roundabout  
**Manufacturer:** Husson UK  
**Surface Type:** Grass Matrix Tiles  
**Item Quantity:** 1  
**Equipment Compliance:** No  
**Surface Area Compliance:** No

The raised concrete base forms a hard object within the falling space of the equipment and there is also insufficient surfacing provided in contravention of BS EN 1176 Part 1 - Extend surface area to comply

The surfacing is severely damaged - Repair damaged areas of surfacing

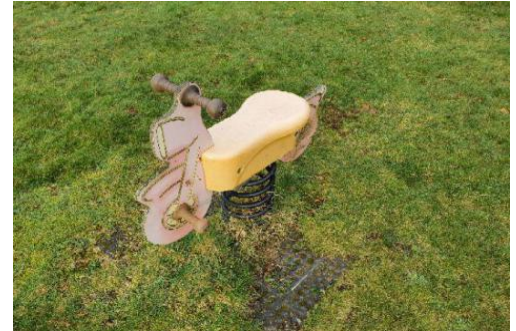
**Item:** Spring Bike  
**Manufacturer:** Husson UK  
**Surface Type:** Grass Matrix Tiles  
**Item Quantity:** 1  
**Equipment Compliance:** Yes  
**Surface Area Compliance:** Yes

The item is slightly loose in its foundations - Monitor for any further deterioration and repair as required

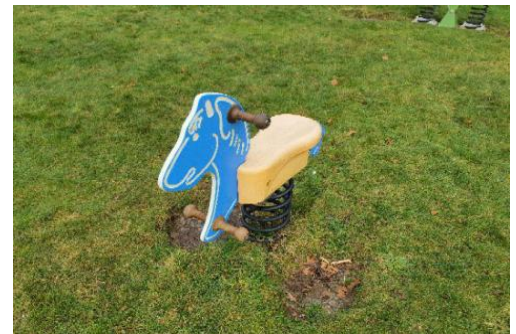
**Item:** Spring Horse  
**Manufacturer:** Husson UK  
**Surface Type:** Grass Matrix Tiles  
**Item Quantity:** 1  
**Equipment Compliance:** Yes  
**Surface Area Compliance:** Yes

The grass mats are silted up and the soil is compacted; this may have an effect on the impact absorbing properties of the surface. Consideration should be given to HIC testing the surface to verify impact attenuating properties ( <https://playinspections.co.uk/inspection-services/safety-surface-testing/> ) - Contact our office for a quotation for this service

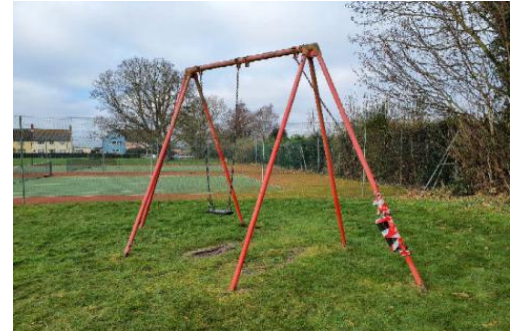
**Item:** 1 Bay 2 Seat (Flat)  
**Manufacturer:** Wicksteed Playgrounds  
**Surface Type:** Grass Matrix Tiles  
**Item Quantity:** 1  
**Equipment Compliance:** No  
**Surface Area Compliance:** Yes

One swing seat has been tied to the frame and has created a possible strangulation point - Remove seat

The chain openings are in excess of 8.6mm and do not meet the recommendations of BS EN 1176 Part 1 - Monitor - No remedial work recommended

The seats are too close to the frame as defined in BS EN 1176 Part 2; this is a low risk failure and no remedial action is required - Monitor - No remedial work recommended

There is some wear to the shackles - Monitor for any further deterioration and replace when 40% worn

There is moderate damage to the surface - Repair the damaged areas of surfacing

The fixings or components for this item were in excess of 2.5m above the standing surface and could not be fully accessed by the inspector. We have completed a visual inspection of the fixings from ground level but a maintenance inspection should be undertaken to assess the condition, security and wear of the components at intervals in accordance with the manufacturers recommendations. - Inspect in accordance with the manufacturers recommendations

There is some notable evidence of chain wear - Monitor for any further deterioration and replace when 40% worn

The connecting pin is showing signs of wear - Monitor for any further deterioration and replace as required

There is minor distortion damage to one of the legs - Monitor for any further deterioration and repair or replace as required

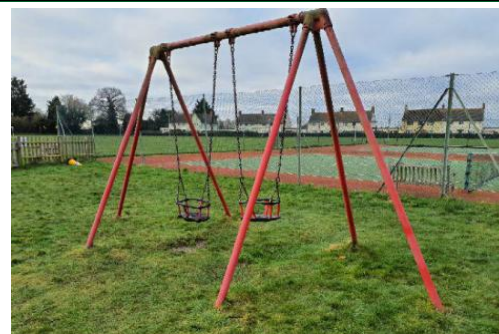
**Item:** 1 Bay 2 Seat (Cradle)  
**Manufacturer:** Wicksteed Playgrounds  
**Surface Type:** Grass Matrix Tiles  
**Item Quantity:** 1  
**Equipment Compliance:** No  
**Surface Area Compliance:** Yes

The seats are not level at rest - Adjust seat to prevent accelerated chain wear

The chain openings are in excess of 8.6mm and do not meet the recommendations of BS EN 1176 Part 1 - Monitor - No remedial work recommended

The connecting pins are showing signs of wear - Monitor for any further deterioration and replace as required

There is some notable evidence of chain wear - Monitor for any further deterioration and replace when 40% worn

The connecting links are in excess of 8.6mm and less than 12mm and fail the requirements of BS EN 1176 Part 1; clause 4.2.13, Chains - Monitor use and replace with compliant links at the next maintenance cycle

The seat has minor damage or wear - Monitor for any further deterioration and replace as required

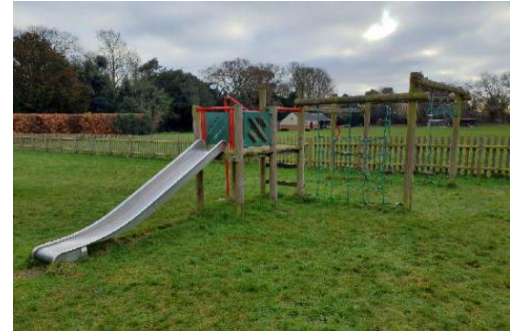
**Item:** Multi Play (Junior)  
**Manufacturer:** Action Play and Leisure  
**Surface Type:** Grass Matrix Tiles  
**Item Quantity:** 1  
**Equipment Compliance:** No  
**Surface Area Compliance:** No

The grass mats are silted up and the soil is compacted; this may have an effect on the impact absorbing properties of the surface. Consideration should be given to HIC testing the surface to verify impact attenuating properties ( <https://playinspections.co.uk/inspection-services/safety-surface-testing/> ) - Contact our office for a quotation for this service

There is/are bolt cap covers missing or damaged on the item - Replace missing or damaged bolt cap covers

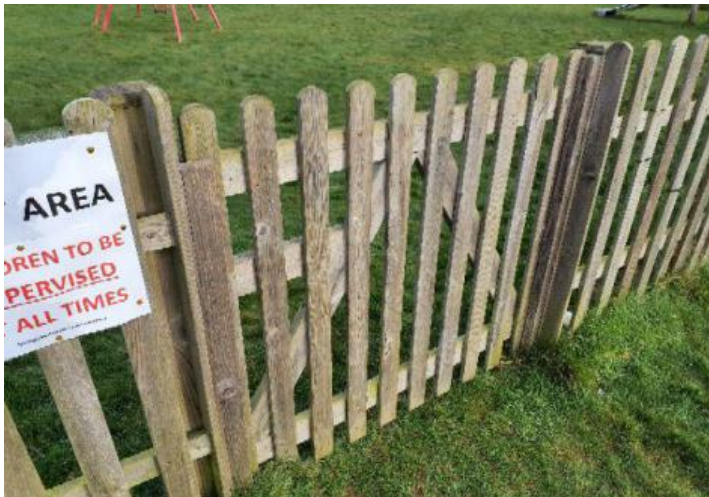
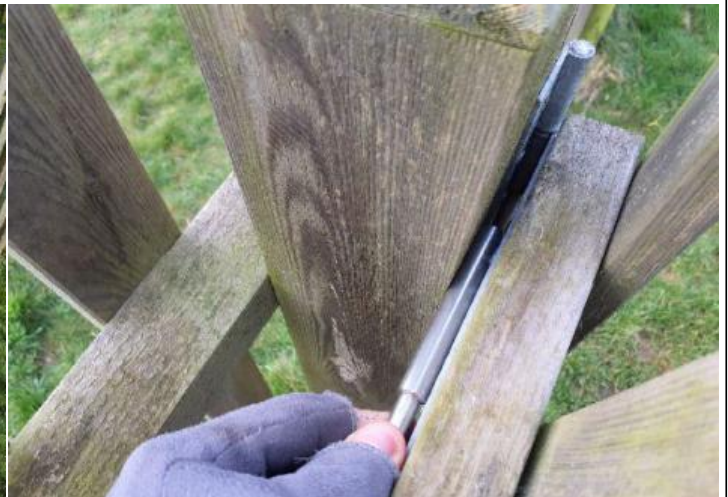
**Item:** Gates - Gate  
**Manufacturer:** Not Identified

**Finding:** There are openings that are less than 12mm that could trap or crush fingers

**Action:** Provide a 12mm gap throughout full range of motion at both sides of gate

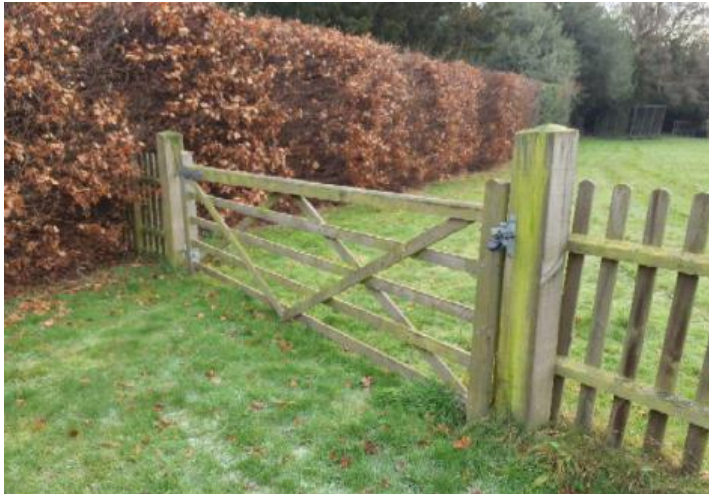
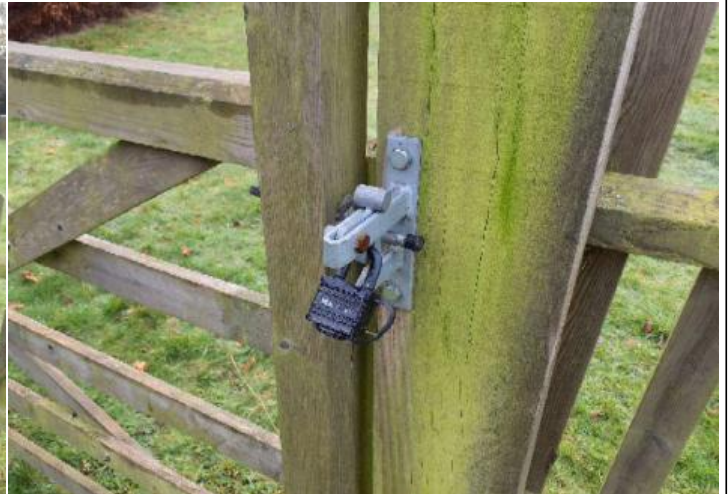
**Item:** Gates - Gate - Maintenance  
**Manufacturer:** Not Identified

**Finding:** The maintenance gate was correctly padlocked at the time of inspection, however this means that the inspector was unable to fully assess the gate

**Action:** Ensure that there are 12mm gaps throughout the full range of motion on gate/s and between leaves where relevant

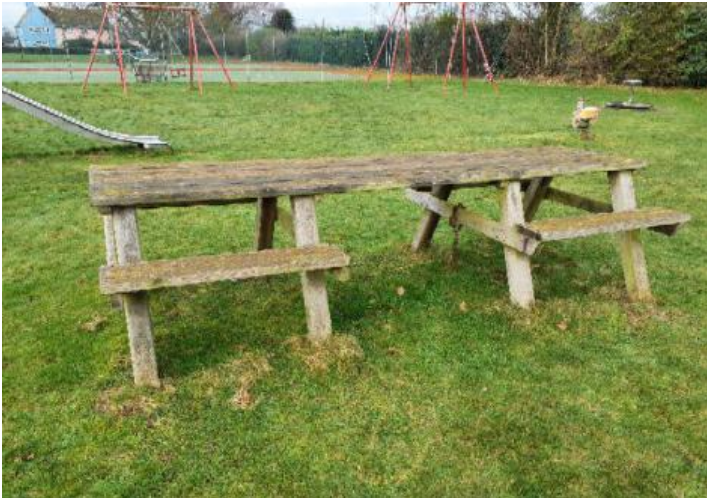
**Item:** Ancillary Items - Picnic Table  
**Manufacturer:** Not Identified

**Finding:** There is some strimmer / machinery damage apparent on the posts, this can penetrate the preservative applied to the timber and accelerate the rotting process

**Action:** Monitor for any deterioration (rot) and replace as required

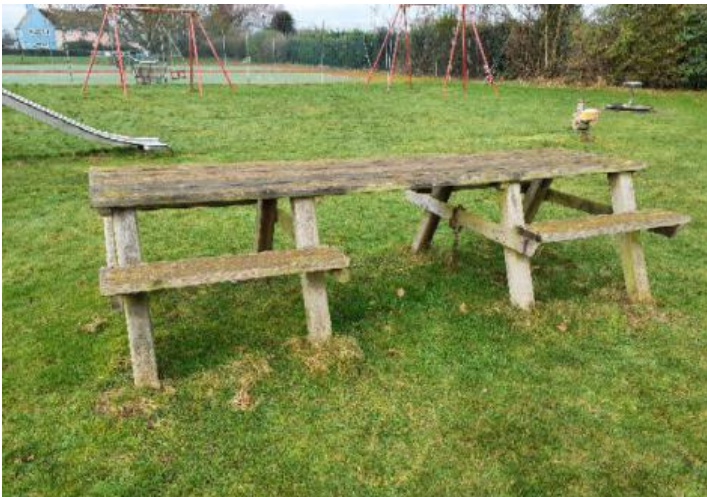
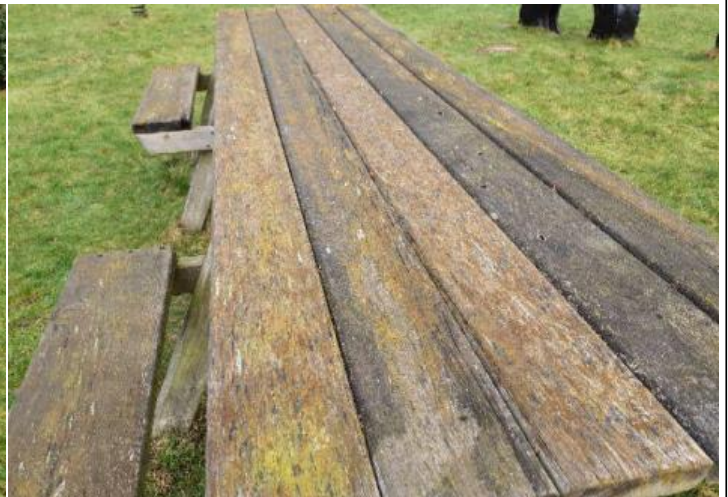
**Item:** Ancillary Items - Picnic Table  
**Manufacturer:** Not Identified

**Finding:** There is algae or moss on the surface of the equipment

**Action:** Clean and treat appropriately

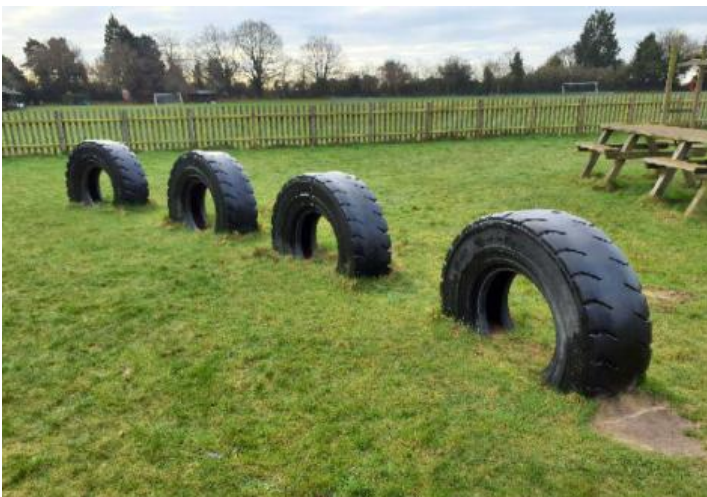
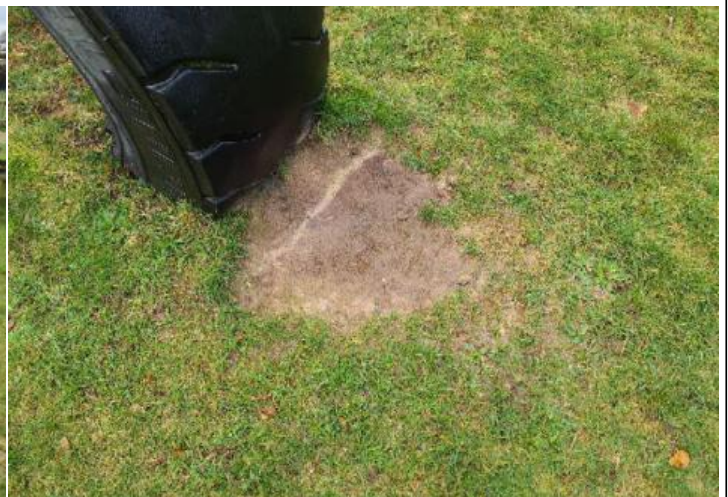
**Item:** Activity Equipment - Tyre Trail  
**Manufacturer:** Not Identified

**Finding:** The grass has eroded within the impact area of the equipment and may not provide the necessary impact attenuating properties for the equipment fall height; the surface may also be slippery in wet weather

**Action:** Reinstate the grass or provide an all weather surface

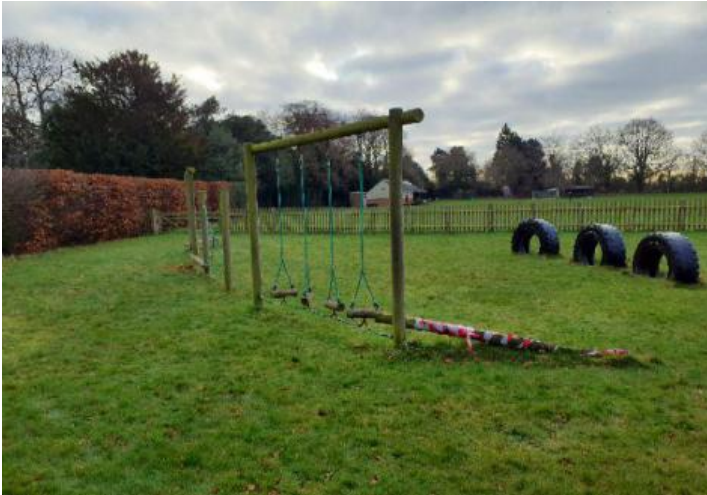
**Item:** Activity Equipment - Activity Trail  
**Manufacturer:** Adventure Playgrounds

**Finding:** The timber on this item has severe rot and there are protruding bolts present

**Action:** Remove and replace all affected timber sections

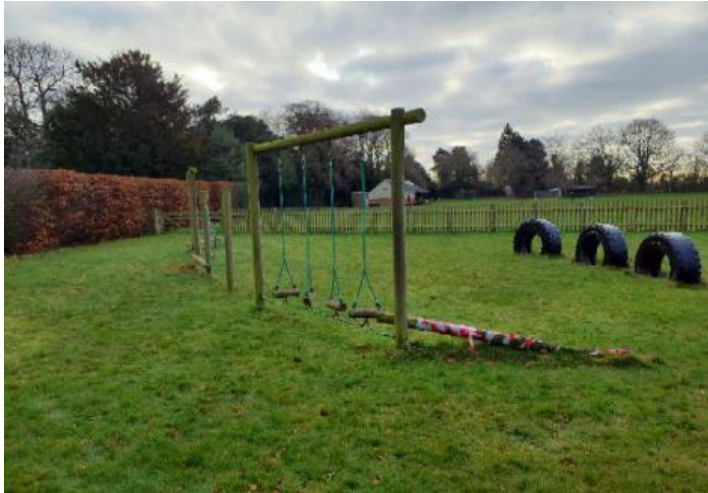
**Item:** Activity Equipment - Activity Trail  
**Manufacturer:** Adventure Playgrounds

**Finding:** The area / equipment on site has been isolated from use however the area is still accessible and the means of isolation has either introduced additional hazards that may cause harm in the event of users accessing the area or is insufficient to stop users from accessing the equipment

**Action:** Provide a more suitable isolation method

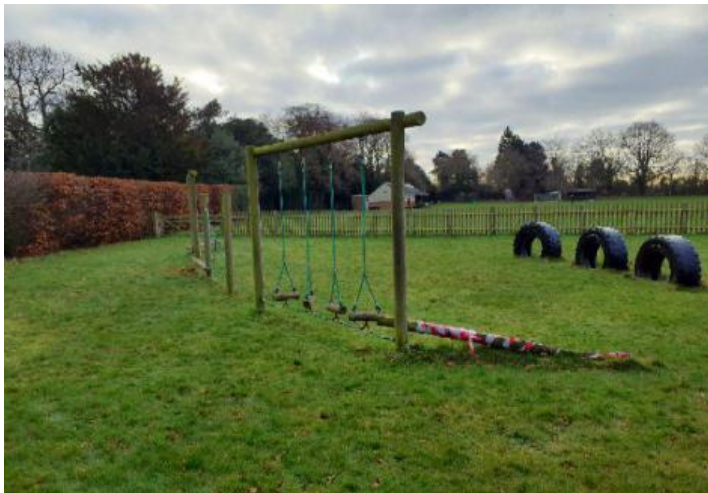
**Item:** Activity Equipment - Activity Trail  
**Manufacturer:** Adventure Playgrounds

**Finding:** There is some strimmer / machinery damage apparent on the posts, this can penetrate the preservative applied to the timber and accelerate the rotting process

**Action:** Monitor for any deterioration (rot) and replace as required

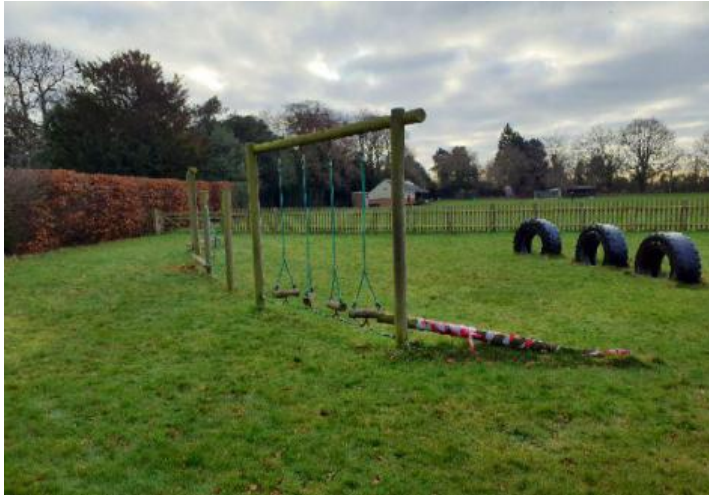
**Item:** Activity Equipment - Activity Trail  
**Manufacturer:** Adventure Playgrounds

**Finding:** There are areas or parts of the timber on the structure that have rotted

**Action:** Replace all affected timbers

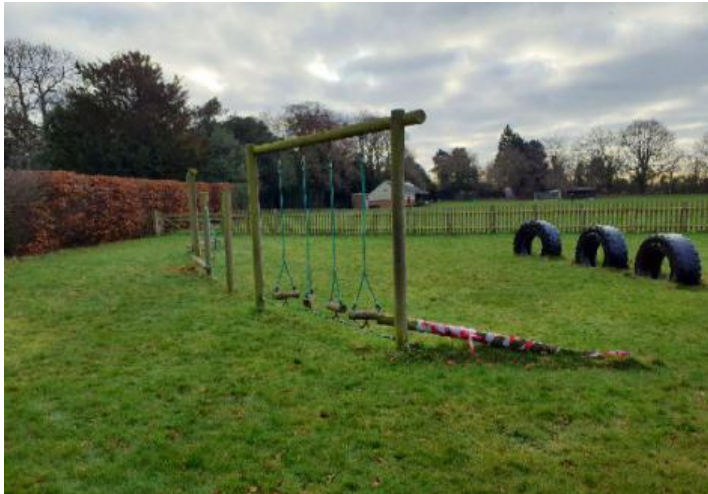
**Item:** Activity Equipment - Activity Trail  
**Manufacturer:** Adventure Playgrounds

**Finding:** There is/are finger entrapment/s in the post due to missing components and the item fails to meet the requirements of BS EN 1176 Part 1 4.2.7.6 Entrapment of fingers

**Action:** Provide missing components to remove entrapment

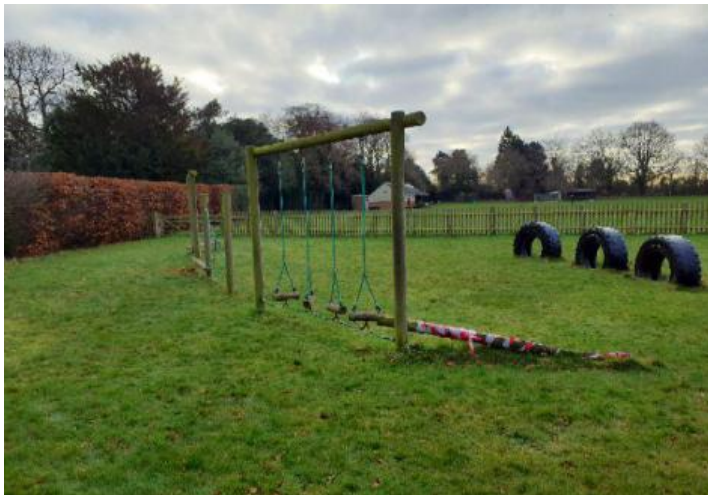
**Item:** Activity Equipment - Activity Trail  
**Manufacturer:** Adventure Playgrounds

**Finding:** There is some notable evidence of chain wear

**Action:** Monitor for any further deterioration and replace when 40% worn

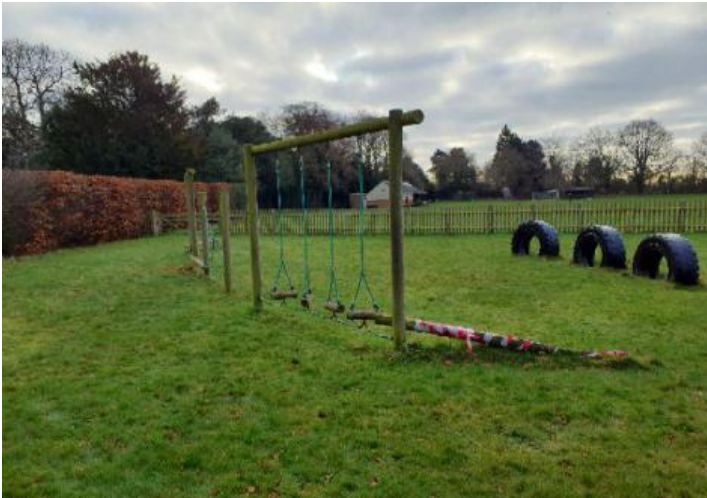
**Item:** Activity Equipment - Activity Trail  
**Manufacturer:** Adventure Playgrounds

**Finding:** The timber has a number of splits/shakes or air cracks and this may affect the stability or allow water ingress which will accelerate the rotting process

**Action:** Monitor to ensure the splits do not cross through fixing points of the structure and/or cause any instability

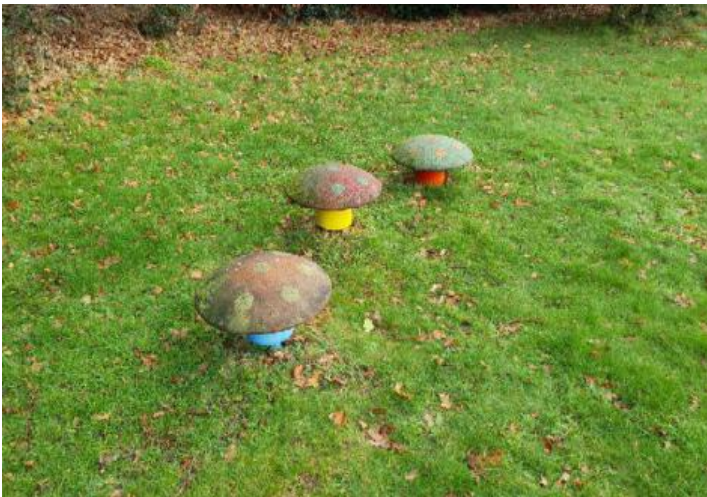
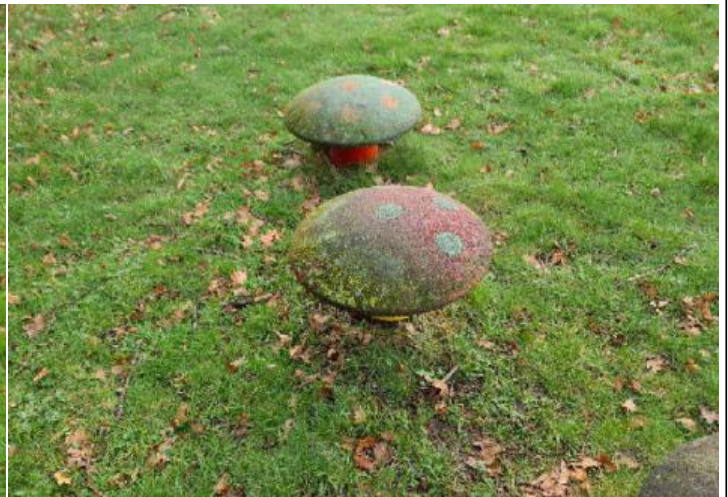
**Item:** Activity Equipment - Toadstools  
**Manufacturer:** Not Identified

**Finding:** There is algae or moss on the surface of the equipment

**Action:** Clean and treat appropriately

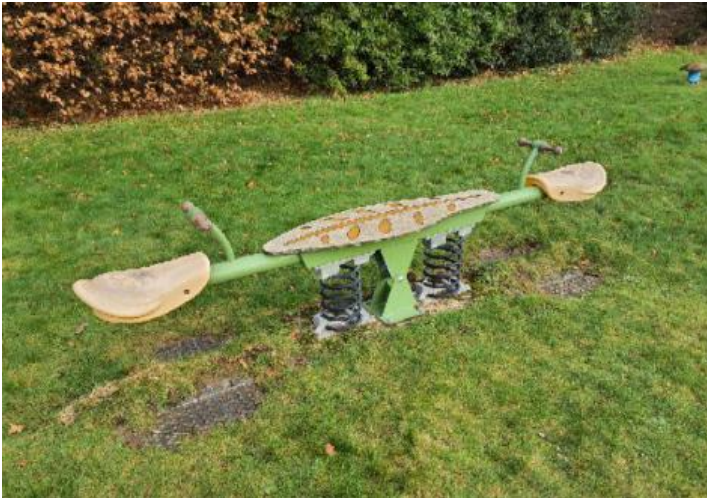
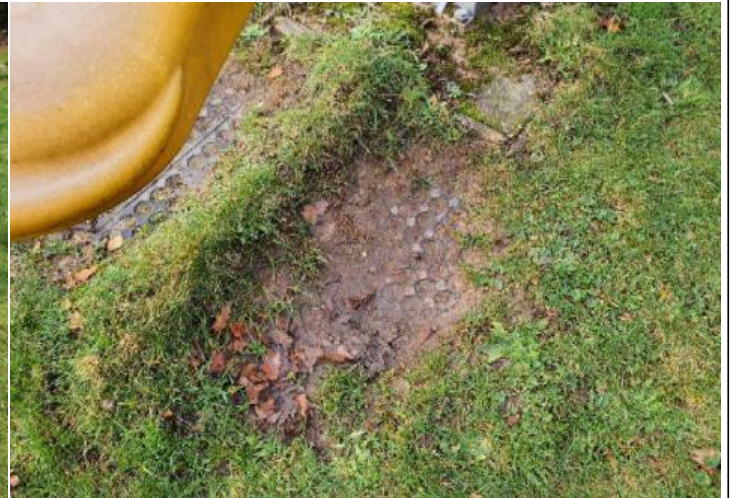
**Item:** Rocking Equipment - Spring See-Saw  
**Manufacturer:** Husson UK

**Finding:** The grass mats are silted up and the soil is compacted; this may have an effect on the impact absorbing properties of the surface. Consideration should be given to HIC testing the surface to verify impact attenuating properties ( <https://playinspections.co.uk/inspection-services/safety-surface-testing/> )

**Action:** Contact our office for a quotation for this service

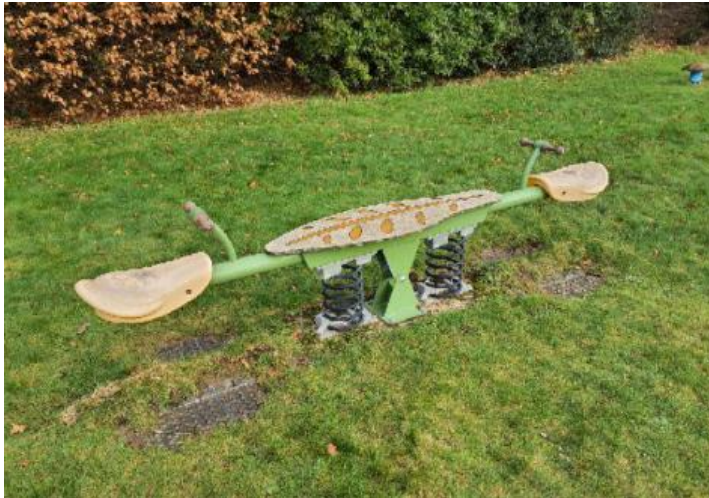
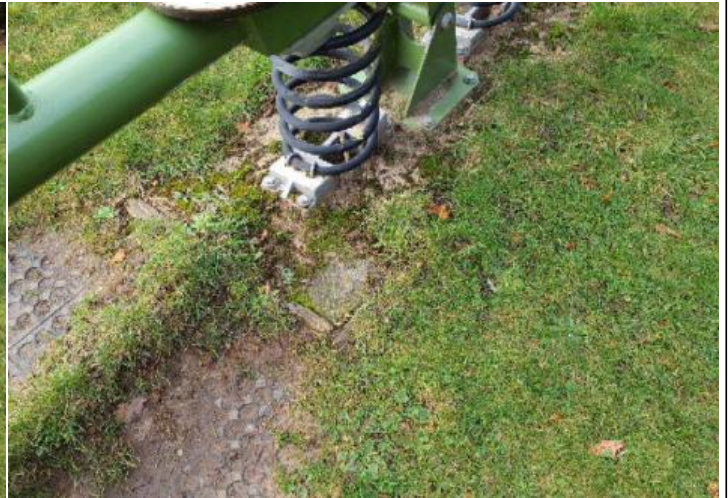
**Item:** Rocking Equipment - Spring See-Saw  
**Manufacturer:** Husson UK

**Finding:** The concrete base/ timber edge forms a hard object within the impact area of the equipment in contravention of the requirements of BS EN 1176 Part 1

**Action:** Provide Impact attenuating surface

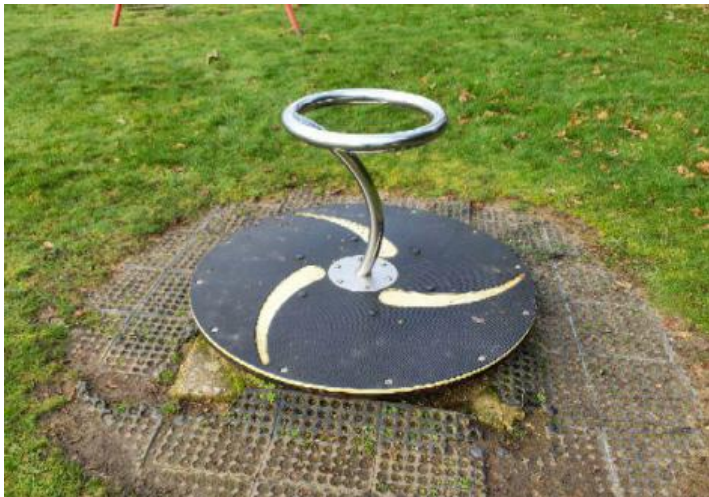
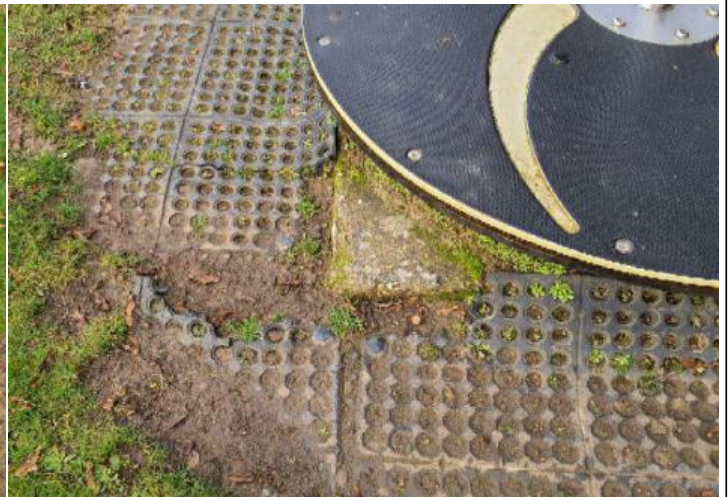
**Item:** Rotor Play - Roundabout  
**Manufacturer:** Husson UK

**Finding:** The raised concrete base forms a hard object within the falling space of the equipment and there is also insufficient surfacing provided in contravention of BS EN 1176 Part 1

**Action:** Extend surface area to comply

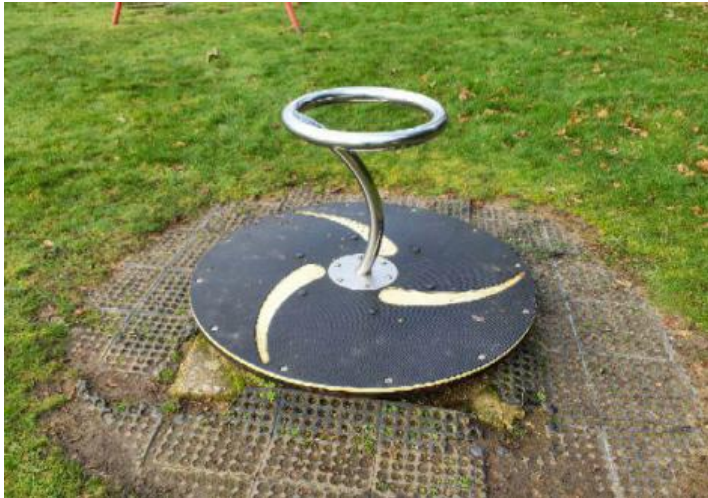
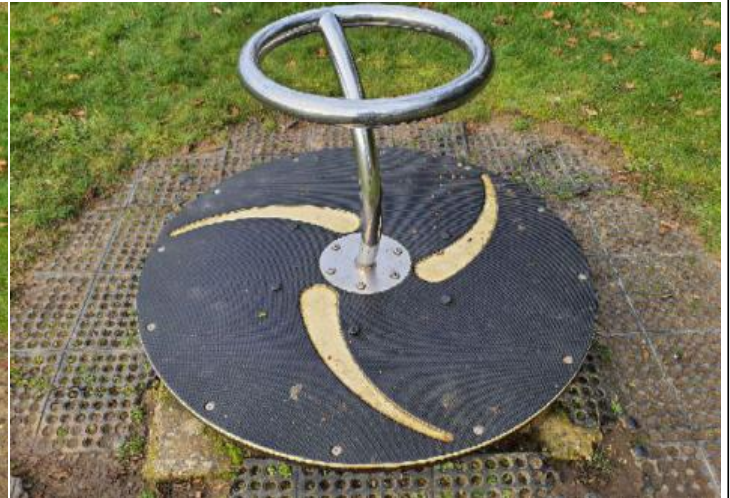
**Item:** Rotor Play - Roundabout  
**Manufacturer:** Husson UK

**Finding:** The bearing on the unit is dry

**Action:** Service and lubricate the bearing(s)

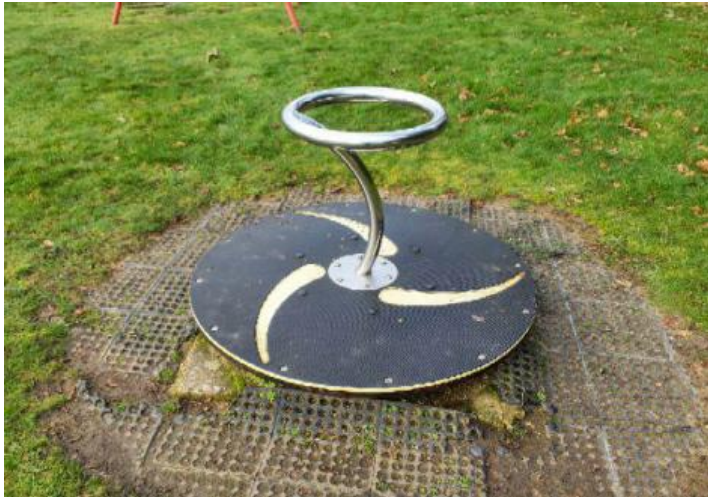
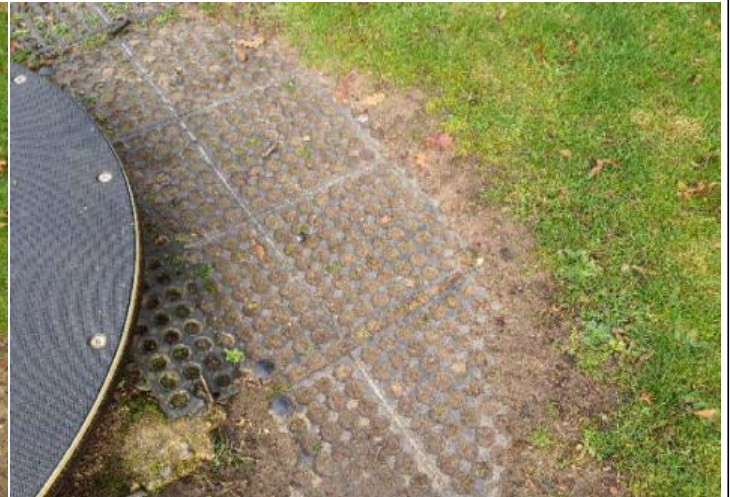
**Item:** Rotor Play - Roundabout  
**Manufacturer:** Husson UK

**Finding:** There are gaps opening between the grass mat tiles

**Action:** Provide additional ties or secure / reinstate surface tiles

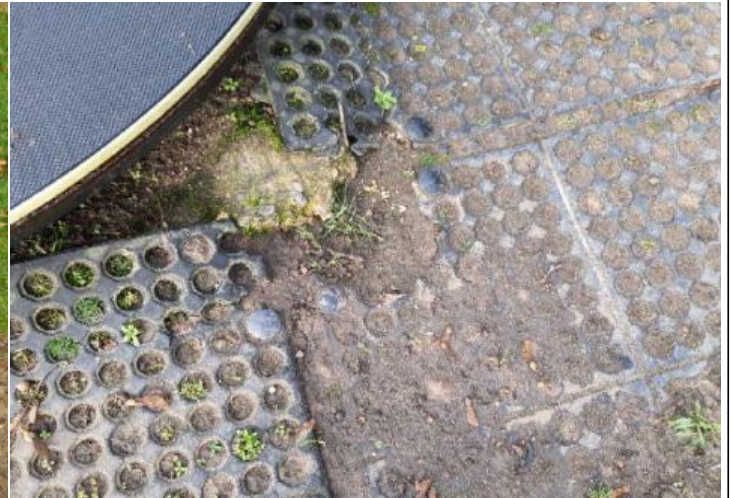
**Item:** Rotor Play - Roundabout  
**Manufacturer:** Husson UK

**Finding:** Fixing Pins have been installed in the impact areas of the grass mats  
**Action:** Remove pins from impact areas

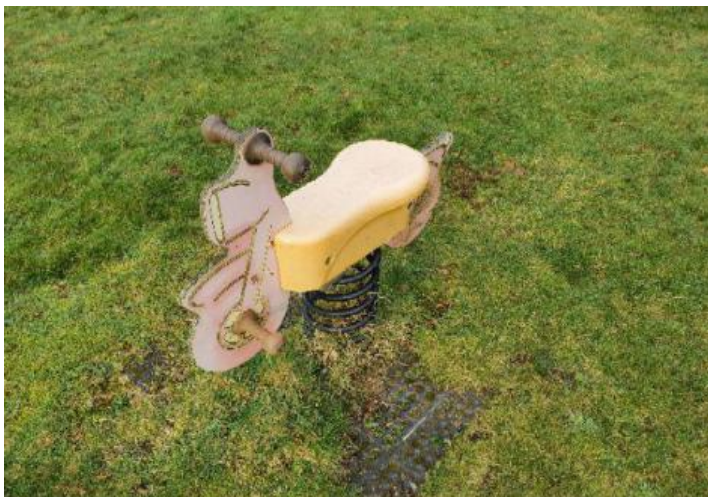
**Item:** Rocking Equipment - Spring Bike  
**Manufacturer:** Husson UK

**Finding:** The item is slightly loose in its foundations

**Action:** Monitor for any further deterioration and repair as required

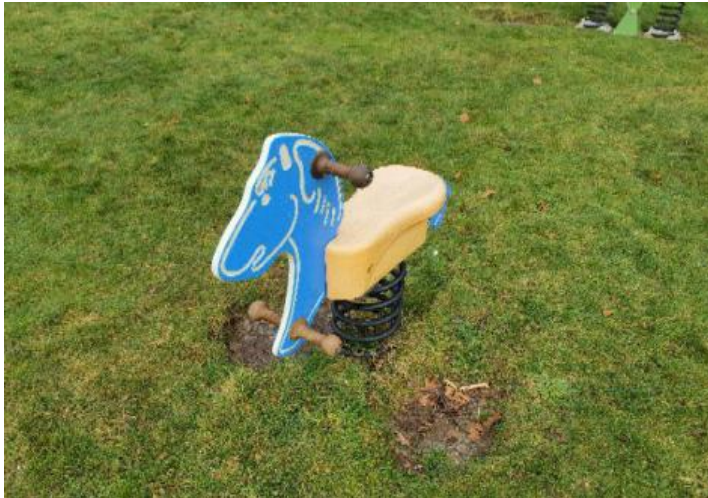
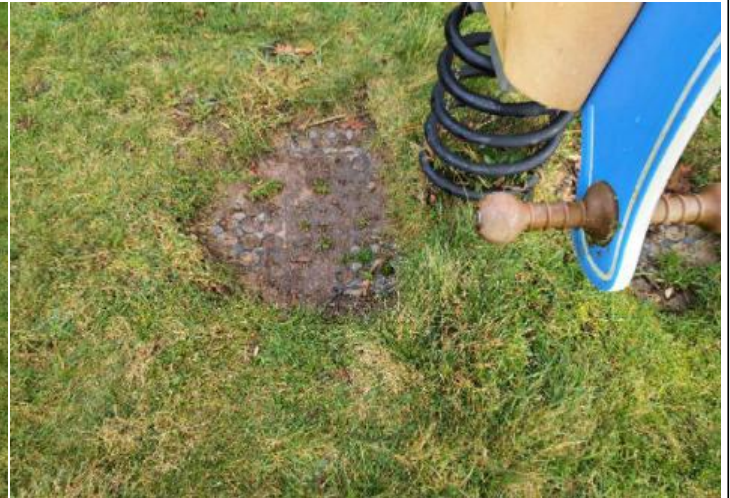
**Item:** Rocking Equipment - Spring Horse  
**Manufacturer:** Husson UK

**Finding:** The grass mats are silted up and the soil is compacted; this may have an effect on the impact absorbing properties of the surface. Consideration should be given to HIC testing the surface to verify impact attenuating properties ( <https://playinspections.co.uk/inspection-services/safety-surface-testing/> )

**Action:** Contact our office for a quotation for this service

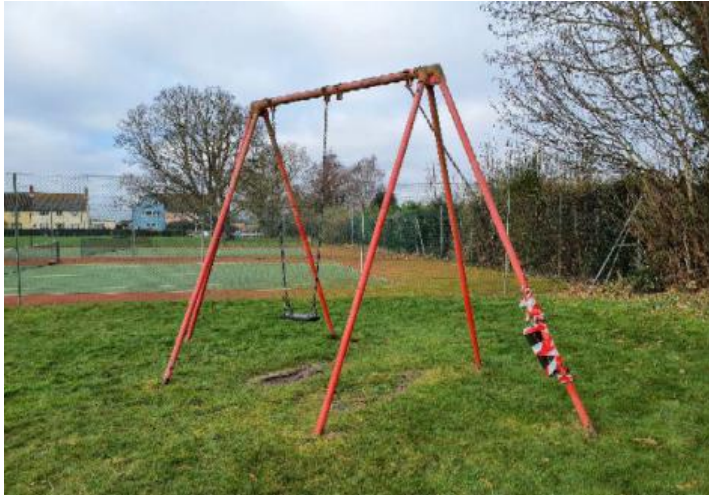
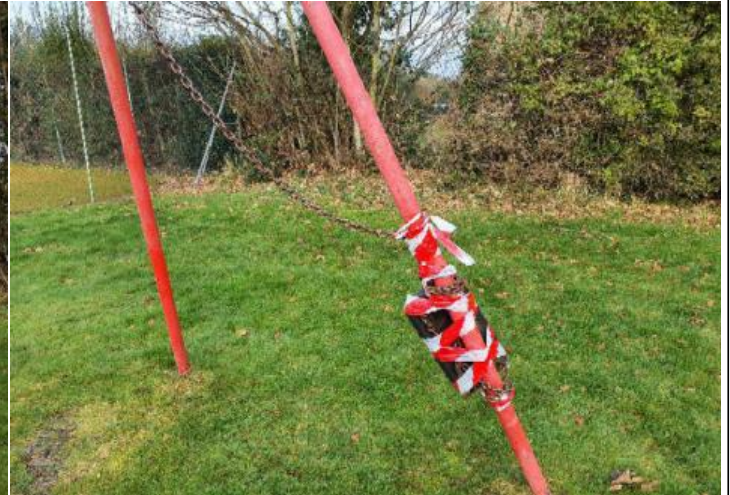
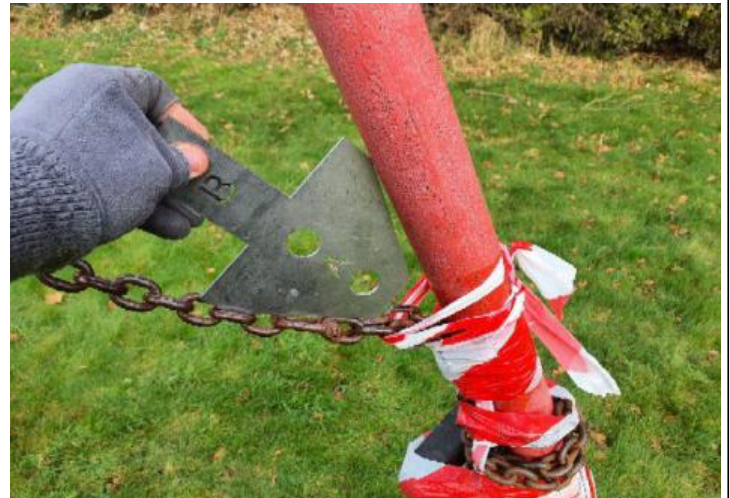
**Item:** Swings - 1 Bay 2 Seat (Flat)  
**Manufacturer:** Wicksteed Playgrounds

**Finding:** One swing seat has been tied to the frame and has created a possible strangulation point **Action:** Remove seat

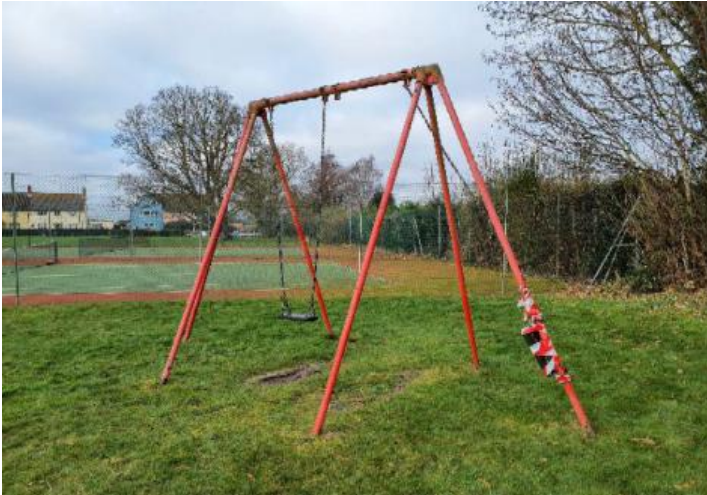
**Item:** Swings - 1 Bay 2 Seat (Flat)  
**Manufacturer:** Wicksteed Playgrounds

**Finding:** There is moderate damage to the surface

**Action:** Repair the damaged areas of surfacing

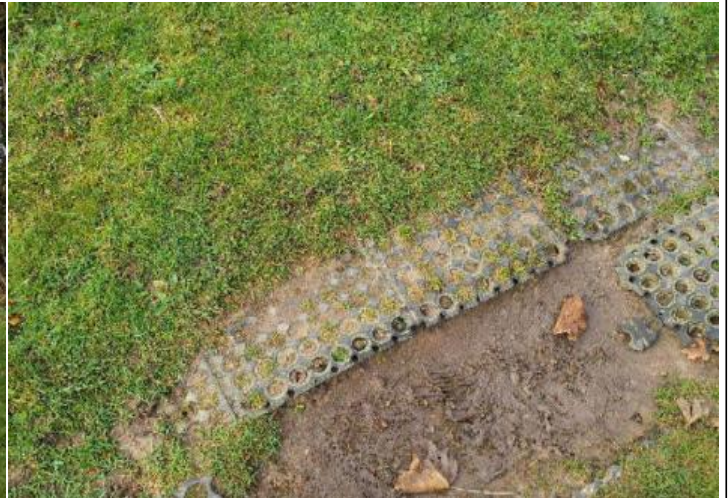
**Item:** Swings - 1 Bay 2 Seat (Flat)  
**Manufacturer:** Wicksteed Playgrounds

**Finding:** The grass mats are silted up and the soil is compacted; this may have an effect on the impact absorbing properties of the surface. Consideration should be given to HIC testing the surface to verify impact attenuating properties ( <https://playinspections.co.uk/inspection-services/safety-surface-testing/> )

**Action:** Contact our office for a quotation for this service

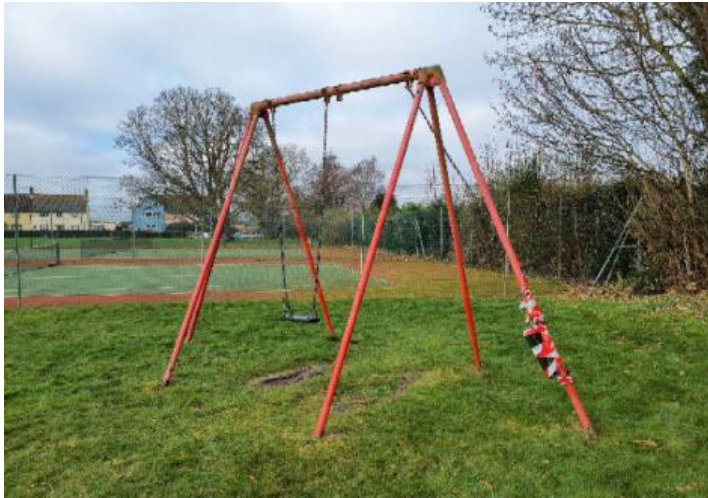
**Item:** Swings - 1 Bay 2 Seat (Flat)  
**Manufacturer:** Wicksteed Playgrounds

**Finding:** The chain openings are in excess of 8.6mm and do not meet the recommendations of BS EN 1176 Part 1

**Action:** Monitor - No remedial work recommended

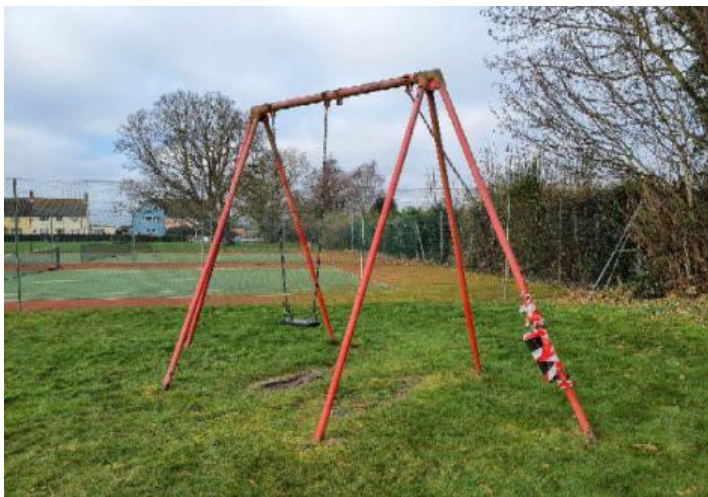
**Item:** Swings - 1 Bay 2 Seat (Flat)  
**Manufacturer:** Wicksteed Playgrounds

**Finding:** There is some notable evidence of chain wear

**Action:** Monitor for any further deterioration and replace when 40% worn

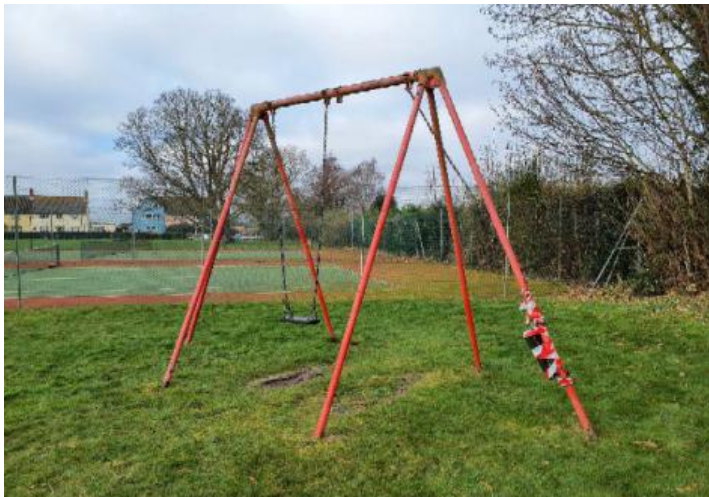
**Item:** Swings - 1 Bay 2 Seat (Flat)  
**Manufacturer:** Wicksteed Playgrounds

**Finding:** The connecting pin is showing signs of wear

**Action:** Monitor for any further deterioration and replace as required
