# TATTINGSTONE

Paper submitted by the Clerk to the Council at the Parish Council meeting on 04 March 2024

### Parish Clerk's Report – March 2024

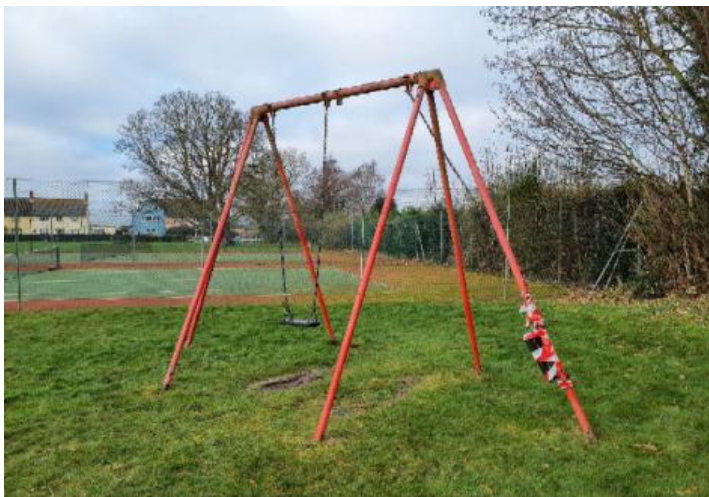
**Item:** Swings - 1 Bay 2 Seat (Flat)  
**Manufacturer:** Wicksteed Playgrounds

**Finding:** There is minor distortion damage to one of the legs **Action:** Monitor for any further deterioration and repair or replace as required

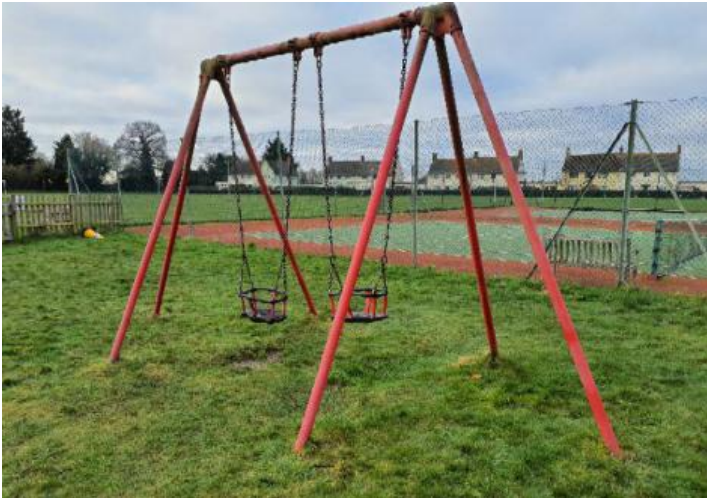
**Item:** Swings - 1 Bay 2 Seat (Cradle)  
**Manufacturer:** Wicksteed Playgrounds

**Finding:** There is some notable evidence of chain wear

**Action:** Monitor for any further deterioration and replace when 40% worn

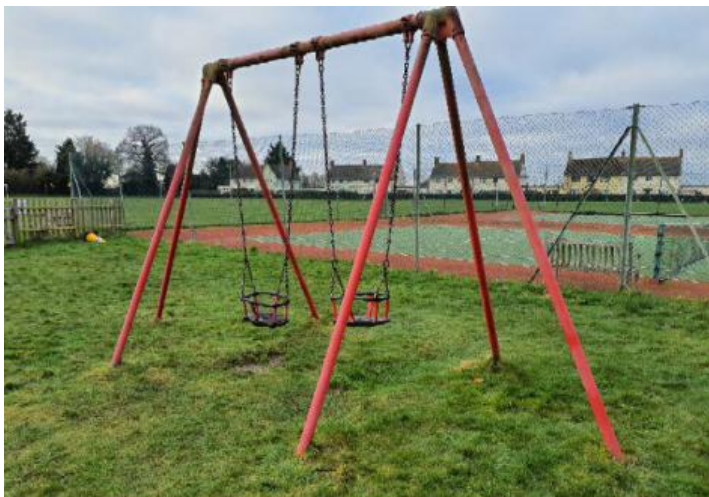
**Item:** Swings - 1 Bay 2 Seat (Cradle)  
**Manufacturer:** Wicksteed Playgrounds

**Finding:** The connecting links are in excess of 8.6mm and less than 12mm and fail the requirements of BS EN 1176 Part 1; clause 4.2.13, Chains

**Action:** Monitor use and replace with compliant links at the next maintenance cycle

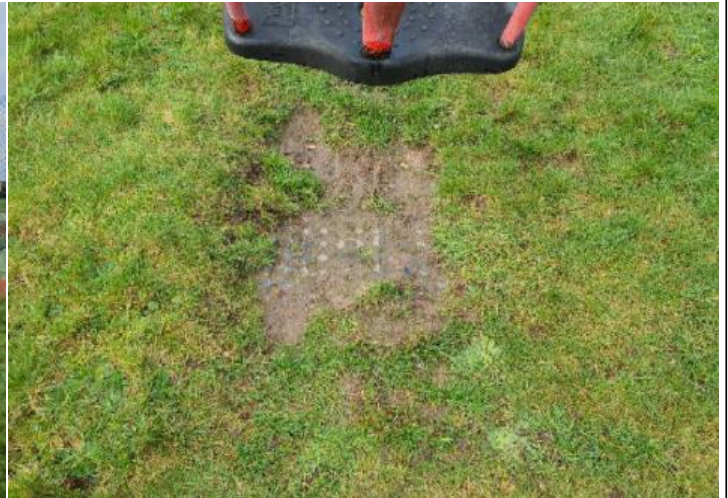
**Item:** Swings - 1 Bay 2 Seat (Cradle)  
**Manufacturer:** Wicksteed Playgrounds

**Finding:** The grass mats are silted up and the soil is compacted; this may have an effect on the impact absorbing properties of the surface. Consideration should be given to HIC testing the surface to verify impact attenuating properties ( <https://playinspections.co.uk/inspection-services/safety-surface-testing/> )

**Action:** Contact our office for a quotation for this service

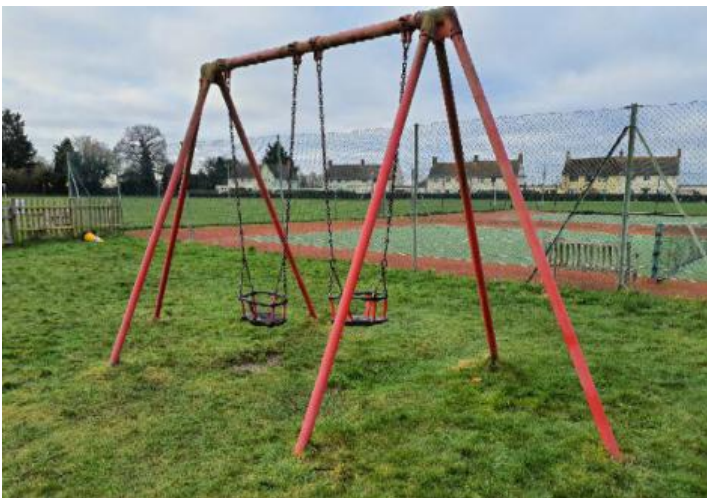
**Item:** Swings - 1 Bay 2 Seat (Cradle)  
**Manufacturer:** Wicksteed Playgrounds

**Finding:** The seat has minor damage or wear

**Action:** Monitor for any further deterioration and replace as required

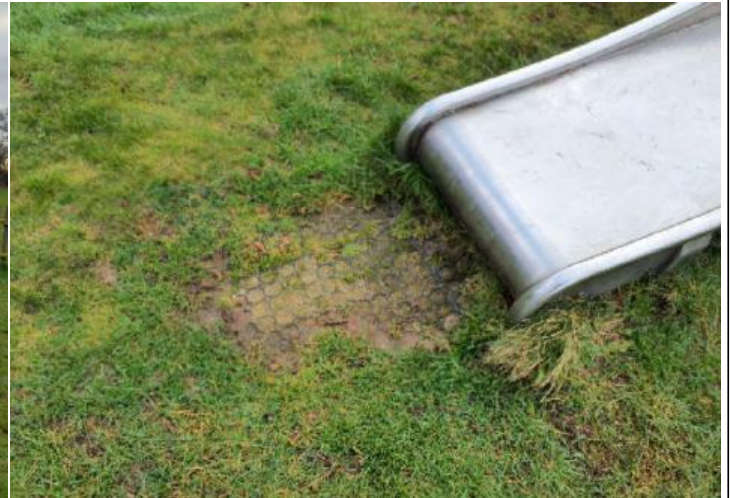
**Item:** Activity Equipment - Multi Play (Junior)  
**Manufacturer:** Action Play and Leisure

**Finding:** The grass mats are silted up and the soil is compacted; this may have an effect on the impact absorbing properties of the surface. Consideration should be given to HIC testing the surface to verify impact attenuating properties ( <https://playinspections.co.uk/inspection-services/safety-surface-testing/> )

**Action:** Contact our office for a quotation for this service

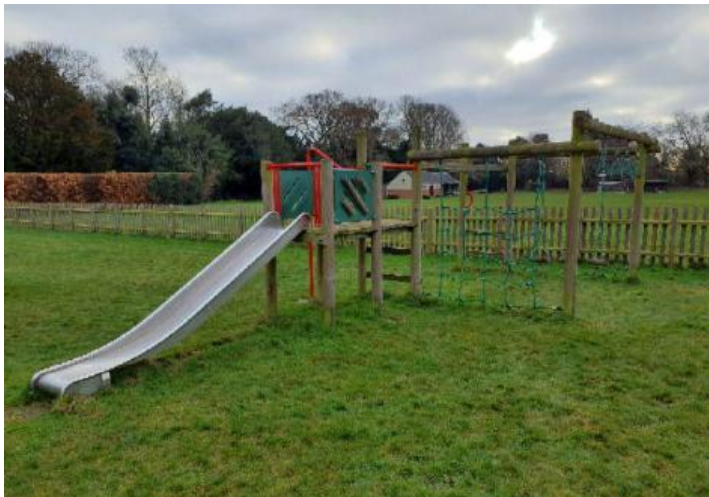
**Item:** Activity Equipment - Multi Play (Junior)  
**Manufacturer:** Action Play and Leisure

**Finding:** There is/are bolt cap covers missing or damaged on the item

**Action:** Replace missing or damaged bolt cap covers

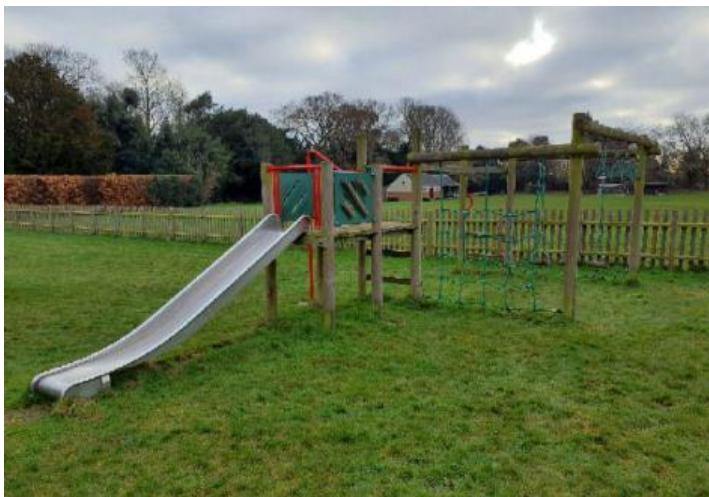
**Item:** Activity Equipment - Multi Play (Junior)  
**Manufacturer:** Action Play and Leisure

**Finding:** There is/are finger entrapment/s in the barrier and the item fails to meet the requirements of BS EN 1176 Part 1 4.2.7.6 Entrapment of fingers

**Action:** Monitor - No remedial work recommended

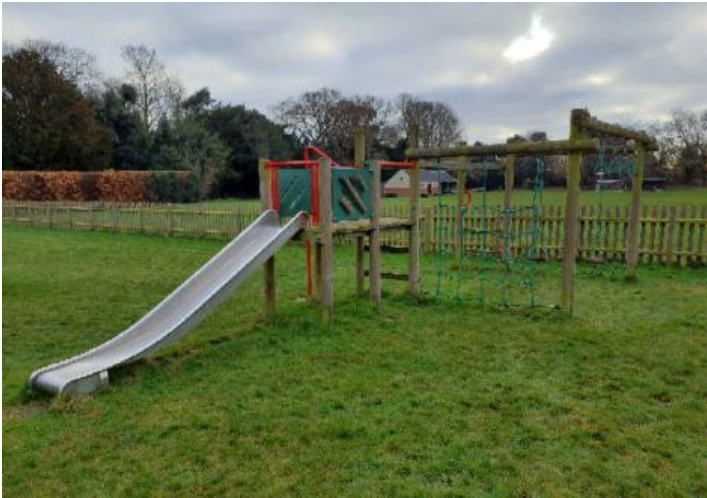
**Item:** Activity Equipment - Multi Play (Junior)  
**Manufacturer:** Action Play and Leisure

**Finding:** There is some evidence of rot in the timber

**Action:** Monitor for any further deterioration and replace as required

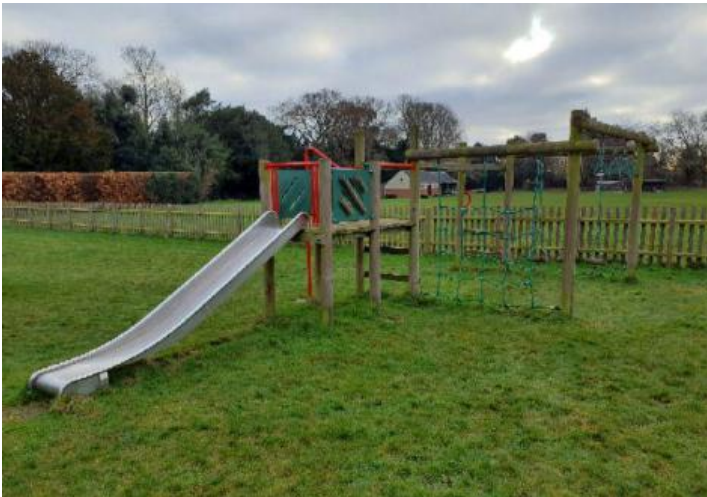
**Item:** Activity Equipment - Multi Play (Junior)  
**Manufacturer:** Action Play and Leisure

**Finding:** A number of fixing(s) have worked loose

**Action:** Secure all loose fixings
